1. INTRODUCTION

1.1 Overview of Mir Photo/TV Survey

3. MIR SURVEY COVERAGE AND SURFACE ASSESSMENT

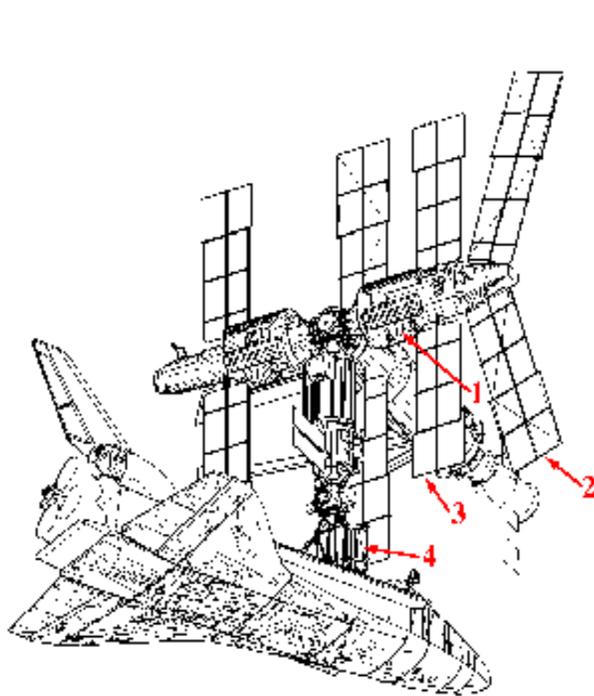
**Figure 3-A STS-76 Damage Survey
(Bottom View)**

1. Spektr radiator with chipped paint.
2. SP#4 Spektr array with surface damage.
3. SP#2 Spektr array with surface damage.
4. Russian Solar Array (RSA) Carrier with discoloration and chipped paint.

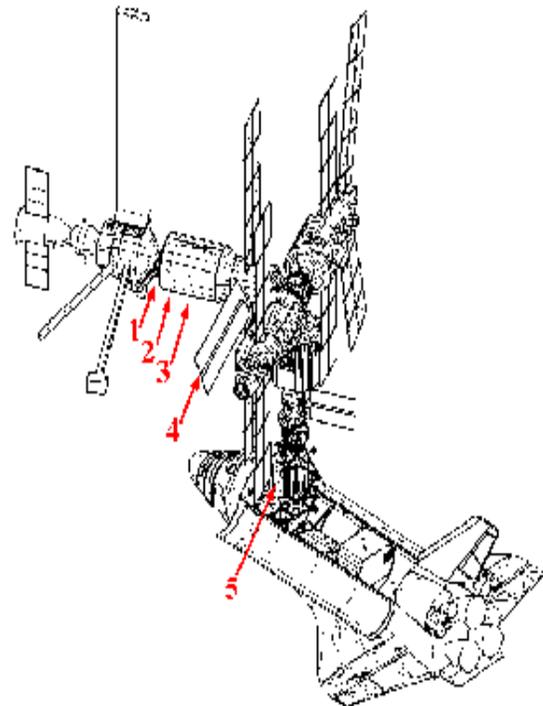
**Figure 3-B STS-76 Damage
Survey (Top View)**

1. Luch antenna discoloration.
2. Base Block surfaces with discolored and chipped paint.
3. Base Block surfaces with chipped paint and micrometeoroid sensor damage.
4. SP#3 Base Block array with surface damage to cells on outer panels.
5. Cooperative Solar Array (CSA) Carrier with discoloration and chipped paint.

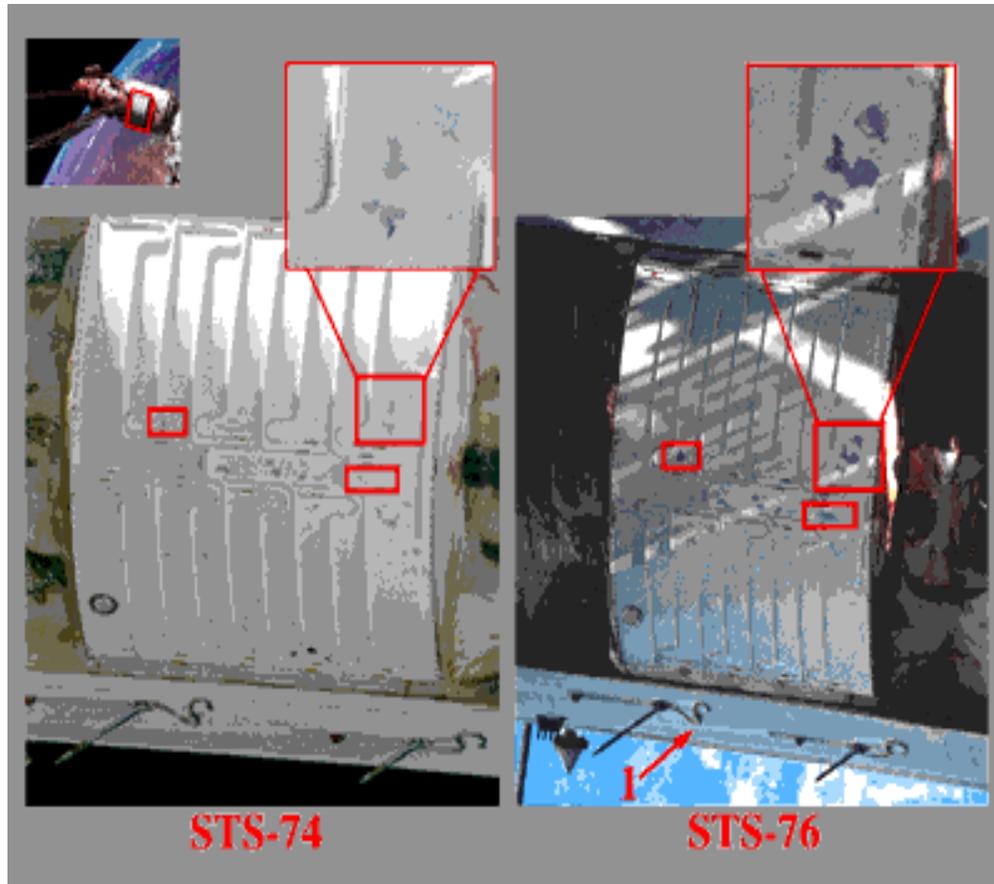
Figure 3-C Spektr Radiator Comparison

Over 50 areas of chipped paint on the surface of the radiator were identified. Correcting for the curvature of the radiator, the area of chipped paint was approximately 800 cm² during STS-74. This area increased in size to approximately 1300 cm² in the four months between STS-74 and STS-76.

The boxes indicate regions of direct correlation between the two missions. In these boxes, the increased area of chipped paint is most readily seen.

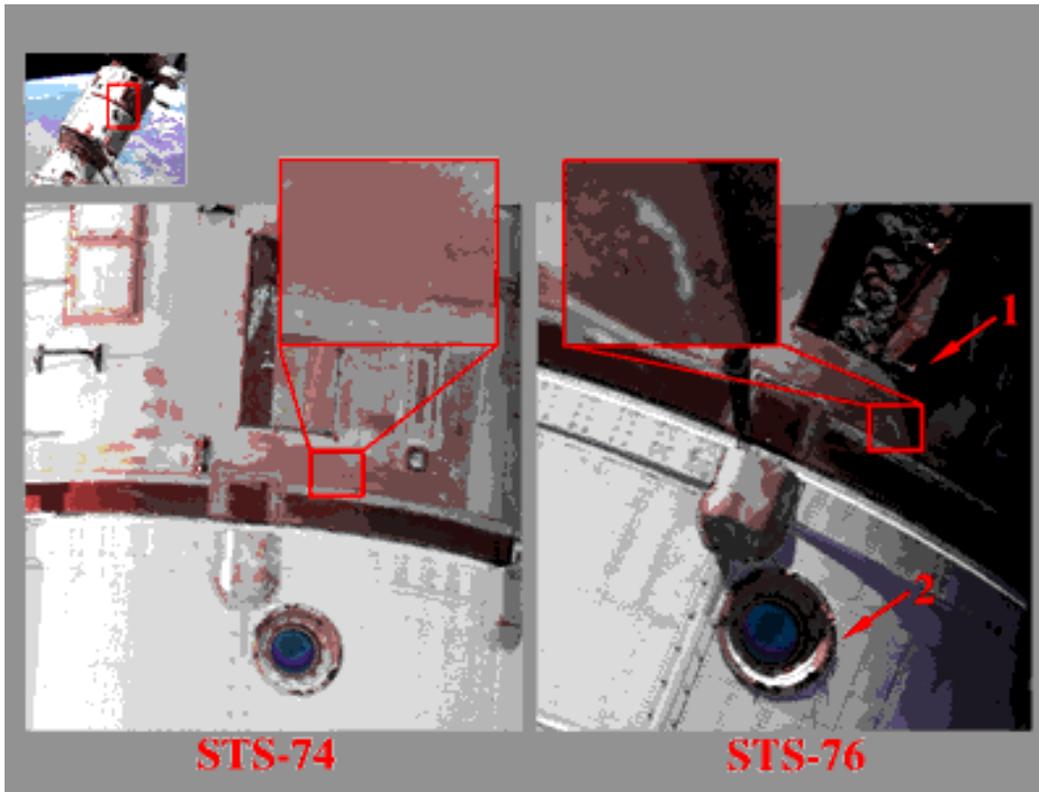
Figure 3-D Base Block Comparison

The highlighted region shows a white area visible on STS-76 which was not present during STS-74. Surface discoloration appears to have been scratched off between these two missions, revealing a white surface below. This scratching may have occurred during a cosmonaut EVA. Discoloration adjacent to this white area appears highly textured. This suggests that the discolored surface material is somehow lifting away from the module.

Item 1 points to the corner of the micrometeoroid sensor which appears to be detached based on the shadows it casts on the module surface. The oblique lighting makes the area lifting up look more dramatic than previous images of the same area and the amount of damage appears to be the same across the two missions. A comparison of imagery taken from the past two missions indicate that the strip was lifted off the surface on STS-74. This strip was measured to be approximately 95 cm by 15 cm in the STS-63 report. The sensor is composed of three of these strips.

Item 2 points to a port window with several areas of chipped paint around its outer edge. The amount of chipping does not appear to have changed between STS-74 and STS-76.

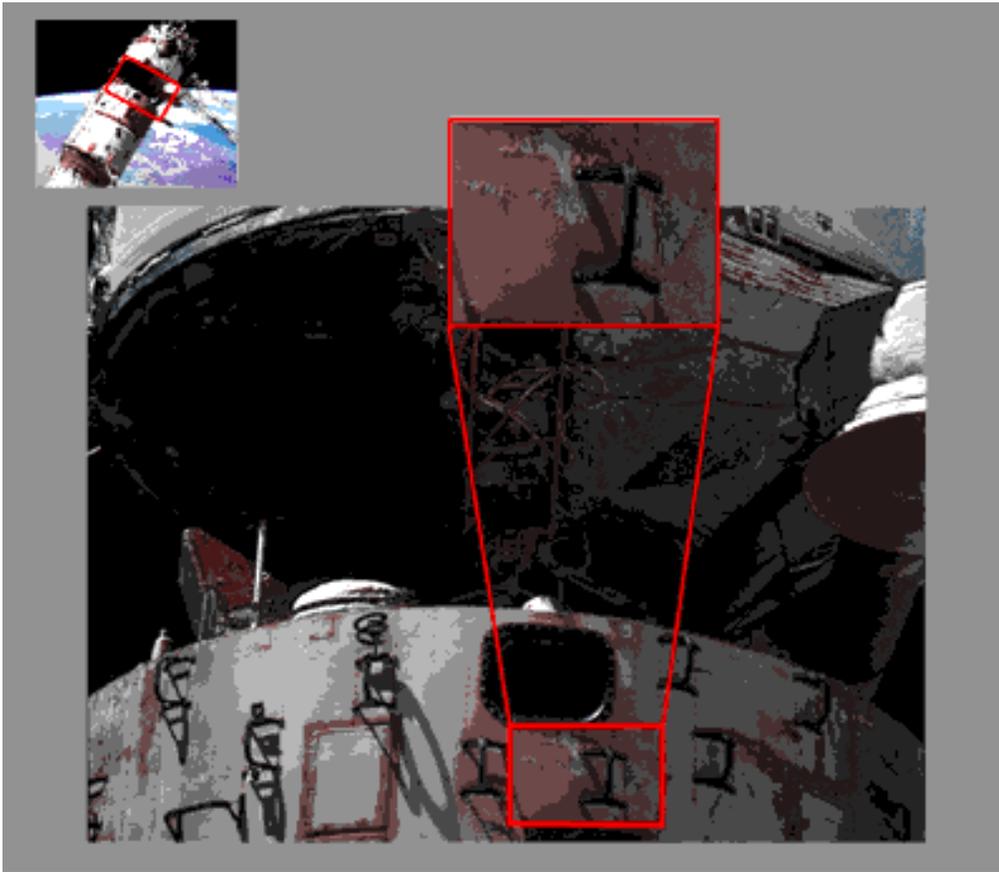
Figure 3-E Base Block

The enlarged area illustrates how discoloration on some areas of the Base Block is blistering and chipping off, revealing the smooth white surface below. The texture of the chipping paint is highlighted by lighting from an oblique angle. The chipping of the discolored area may have been caused by cosmonauts during an EVA. This is especially likely since the region highlighted in this image is surrounded by the hand holds that cosmonauts use for movement around the surface of Mir. The area of blistering and chipping paint appears the same as it did on STS-74.

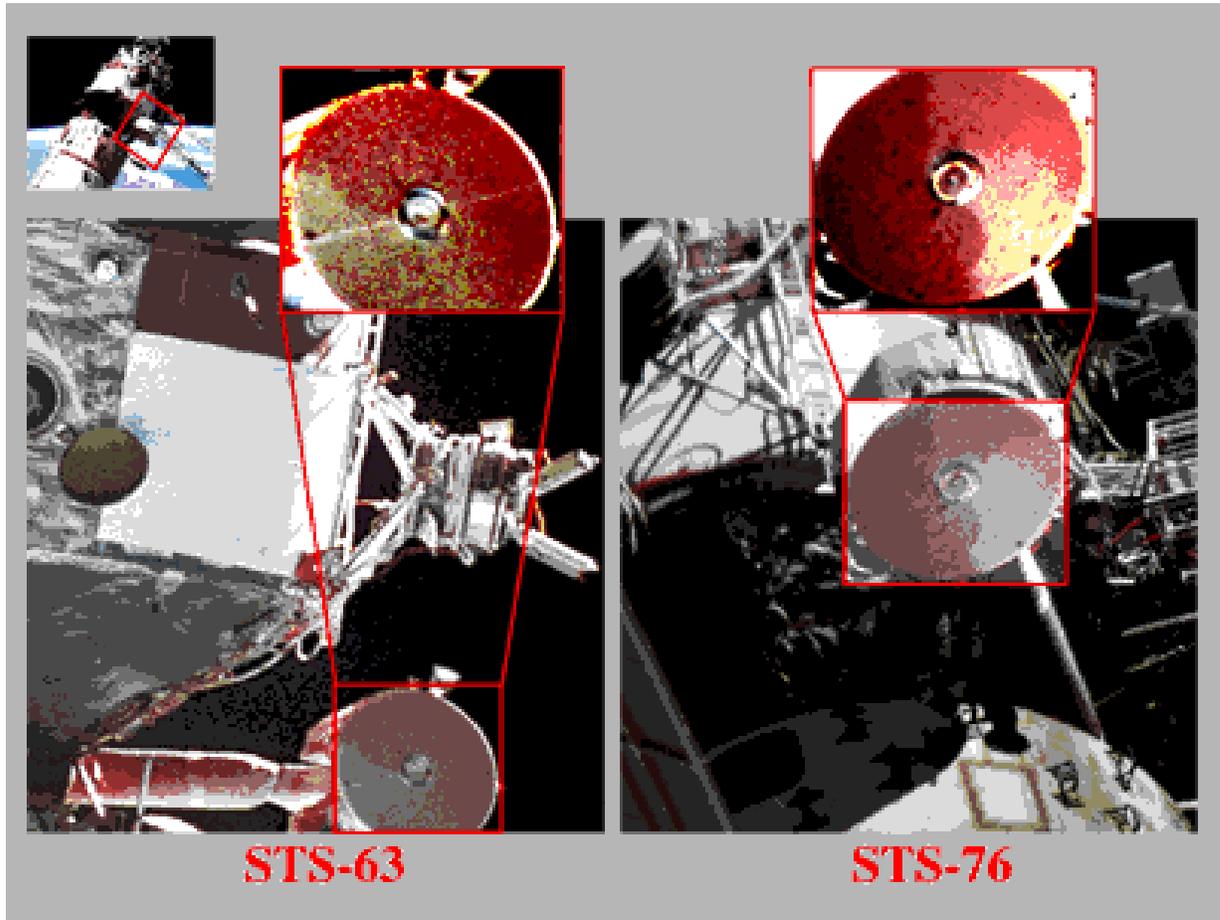
Figure 3-F Luch Antenna Dish Comparison

Figure 3-F shows the front face of the Luch antenna dish. Although the difference between discoloration patterns appears significant, much of this is due to the sharpness difference between the two images. Other factors such as lighting and the resolving power differences between the Nikon (STS-63) and Hasselblad (STS-76) must also be considered when comparing these frames. A detailed examination indicated that the pattern of discoloration on the dish was actually very similar across both missions. This would indicate that the phenomena which caused most of the visible discoloration occurred prior to STS-63 and that no significant changes have occurred since.

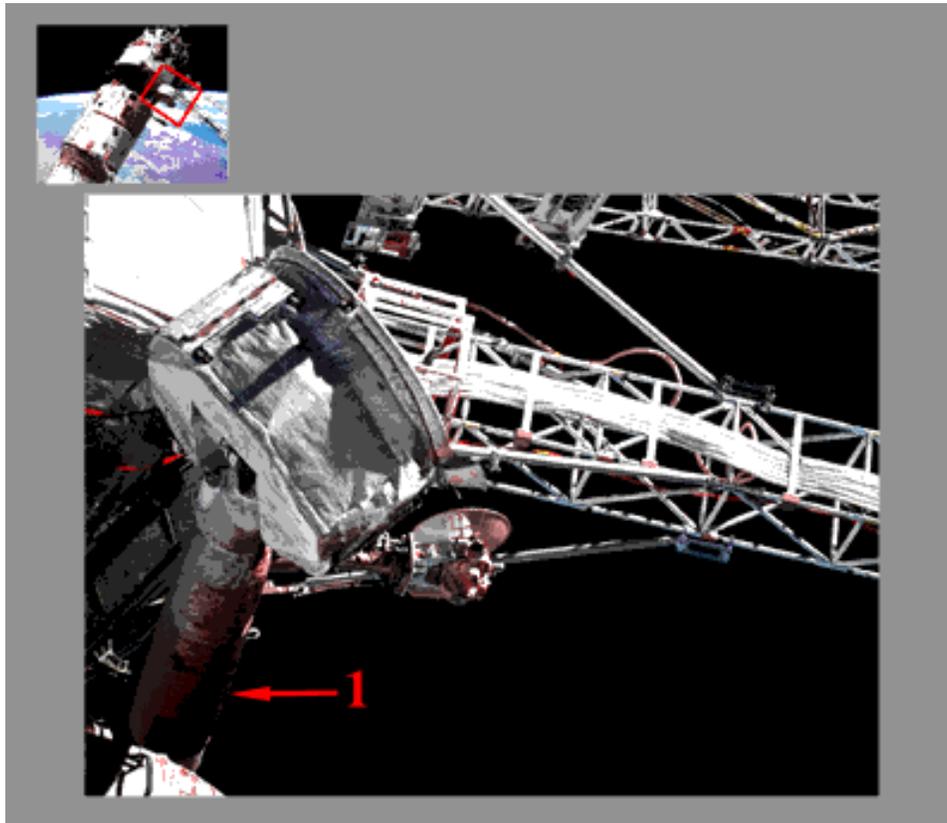
Figure 3-G Arm of the Luch Antenna

The contamination on the arm of the Luch antenna (Item 1) appears to be caused by the same source as that discoloring the end cone of Kvant since the color and pattern of discoloration appears the same as that on the end cone. Materials specialists believe this may be related to fuel line purges. Thermal control system leaks may also contribute to the problem.

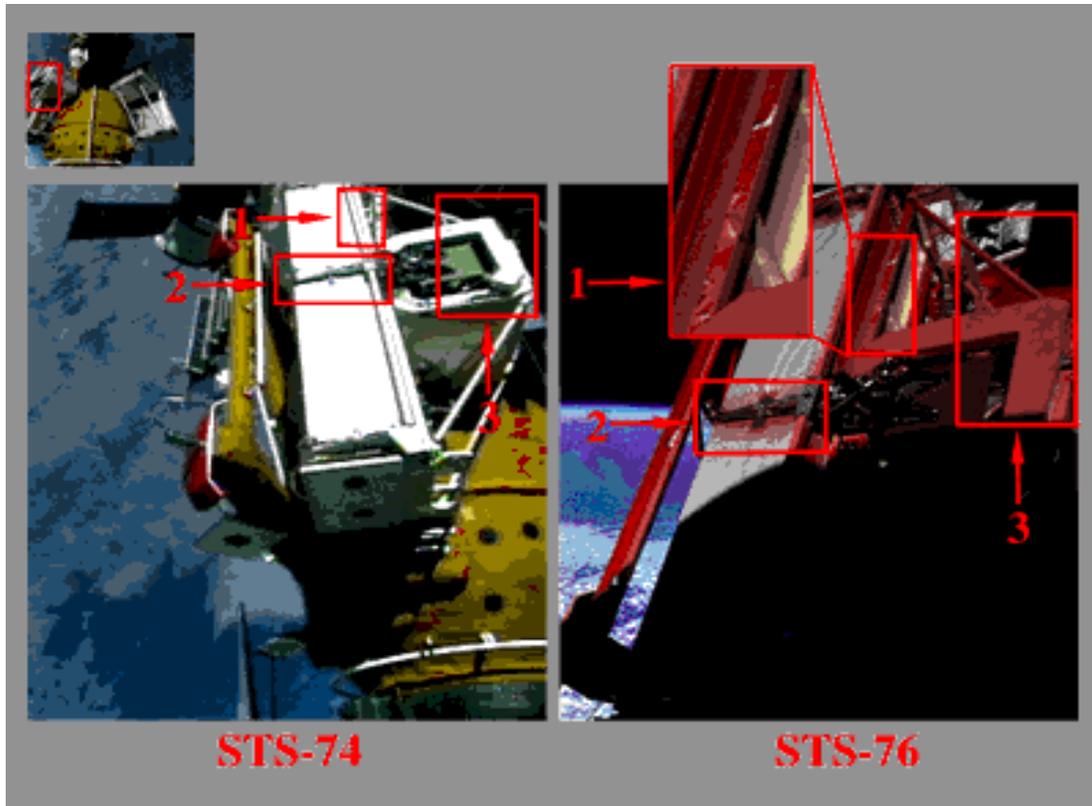
Figure 3-H Russian Solar Array Carrier Comparison (top)

STS-76 imagery shows paint blistering and chipping on two areas of the RSA.

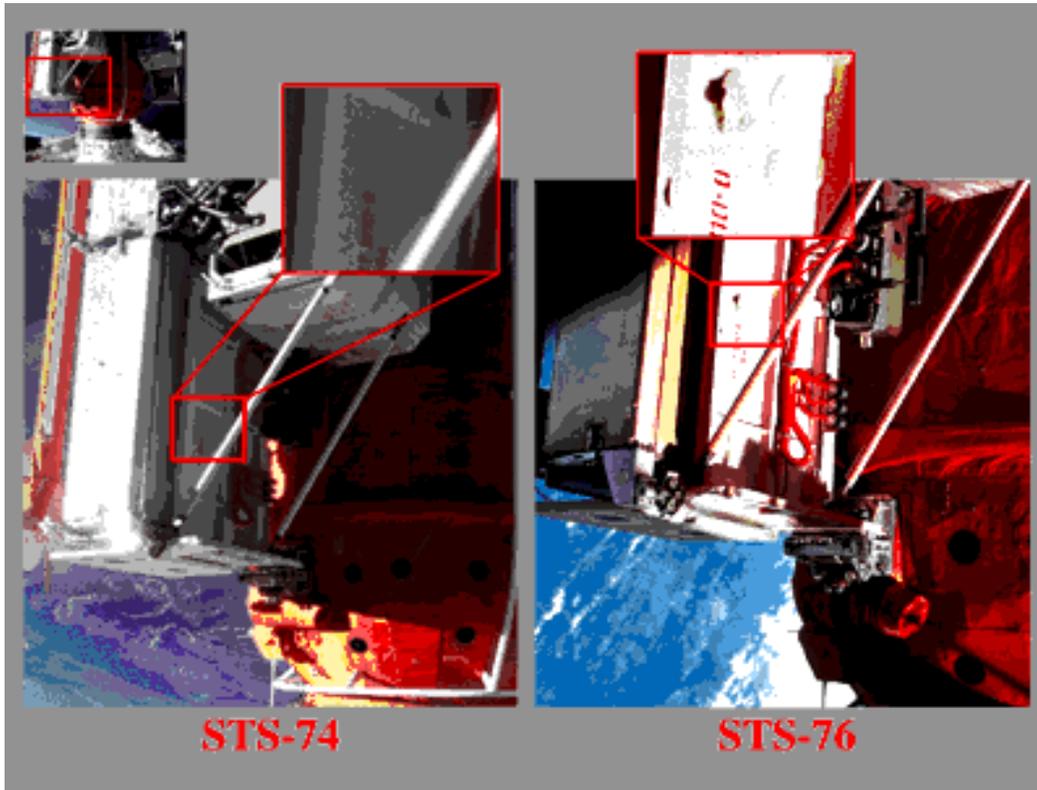
Figure 3-I Russian Solar Array Carrier Comparison (bottom)

The figure above illustrates where paint is chipping along the RSA carrier. In addition, areas along the solar array panels and support arms, which are discolored in the image taken during STS-76, appear white after the Docking Module was installed on STS-74. Note that although shadows affect the color composition of surface features on these images, the uniformity of color along edges seen on STS-74 is in direct contrast to the variation on STS-76. This would indicate the pattern of discoloration is real and not simply variations caused by change in lighting conditions.

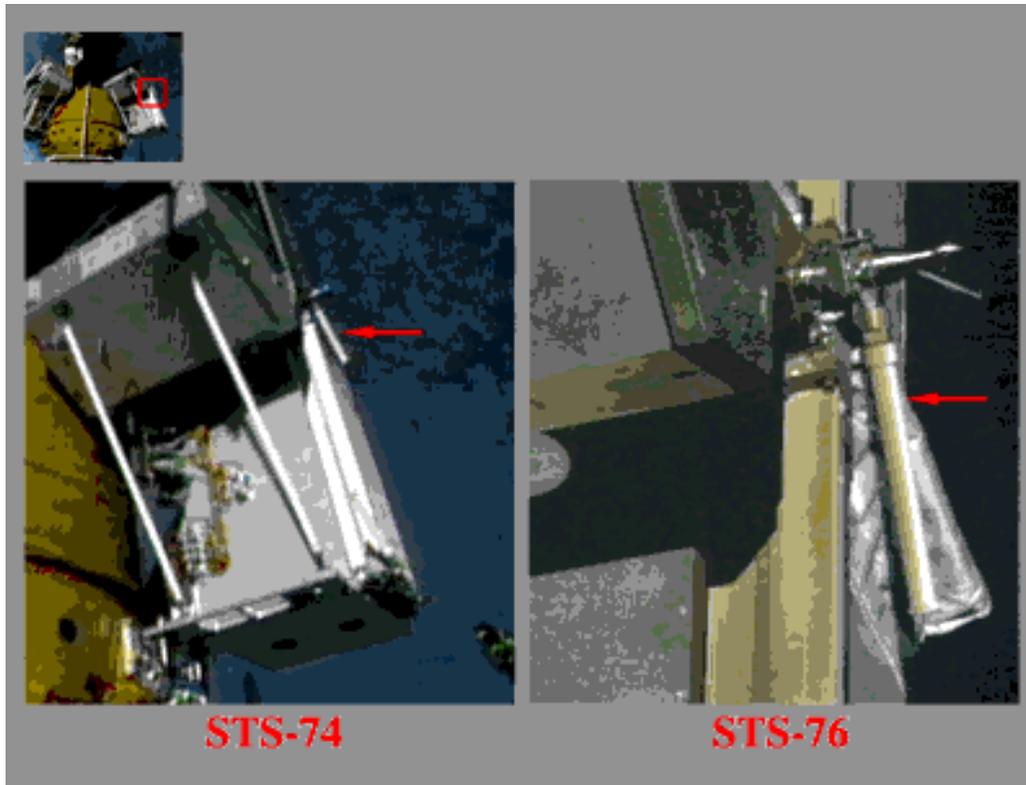
Figure 3-J Cooperative Solar Array Carrier Comparison

Figure 3-J shows areas of discoloration on the CSA structure visible during STS-76. One example of this is the feature attached to the carrier (identified by arrows) in the figure above. The entire pipe appears white on STS-74 video imagery. However, after only four months, one side of the pipe has a brown discoloration, while the other appears to retain its original white color.

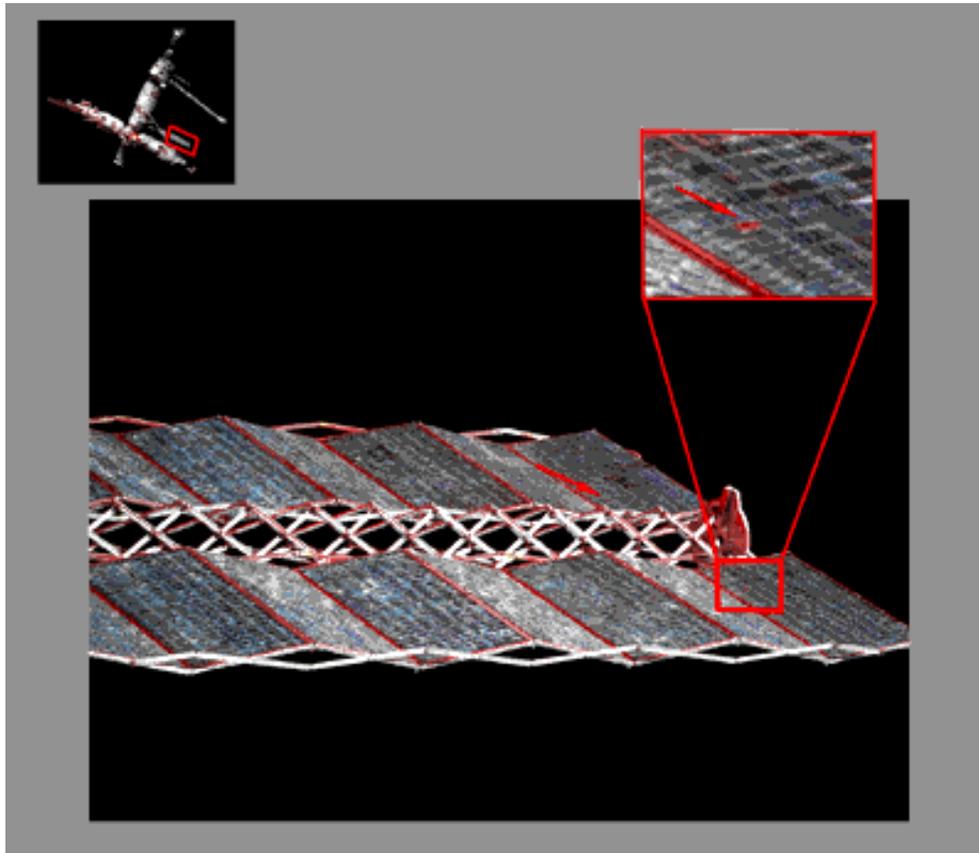
Figure 3-K SP#3 Base Block Array

The arrow in the enlarged image points to a damaged cell on the outer panel of the array. The damage appears to be limited to the cell's top layer and may indicate delamination. A cell on an adjacent panel showing similar damage is identified on the overview image. Each cell measures approximately 4 cm² in area.

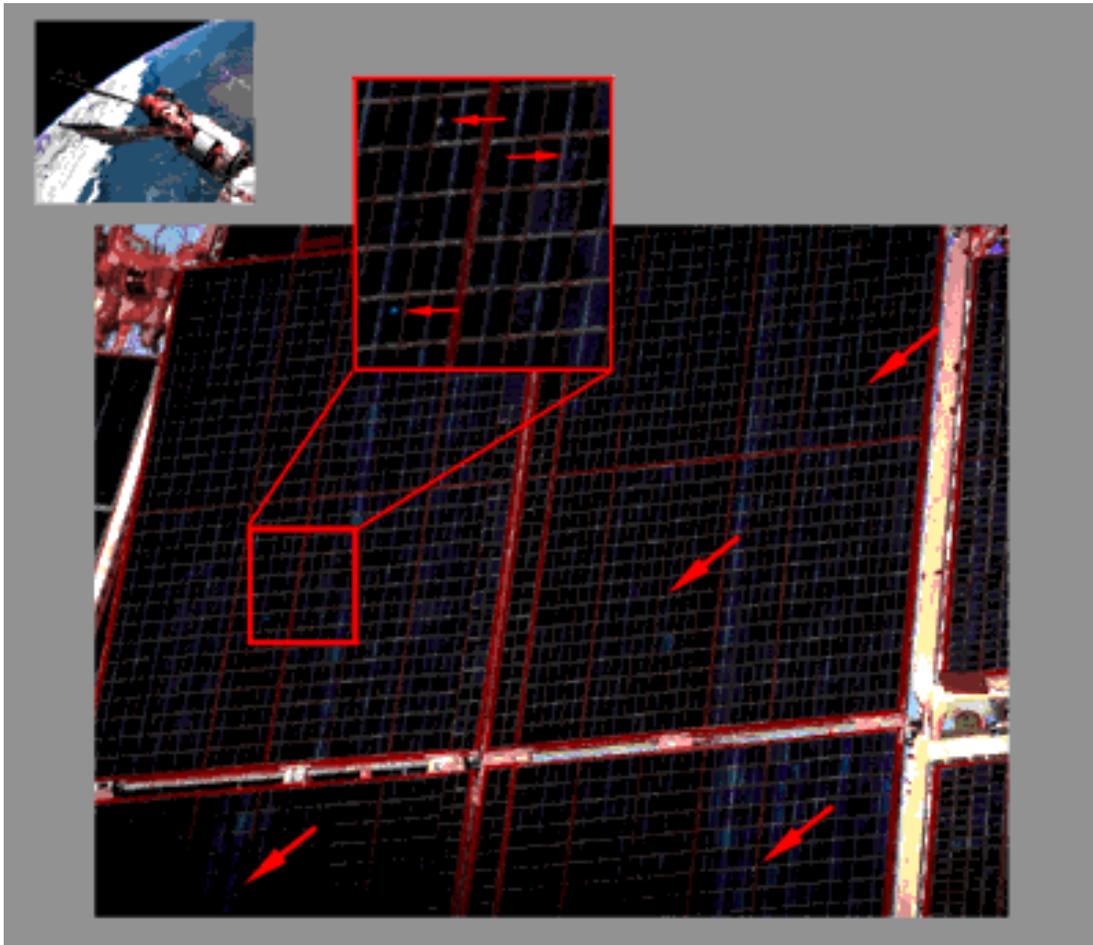
Figure 3-L SP#2 Spektr Solar Array

The arrows in the enlarged region and the arrows on the solar array itself indicate small regions of discoloration. These points, which are lighter in color than the solar cells, may identify possible debris strikes. There are 10 points of discoloration on the array, ranging in diameter from approximately 0.4 to 0.7 cm.

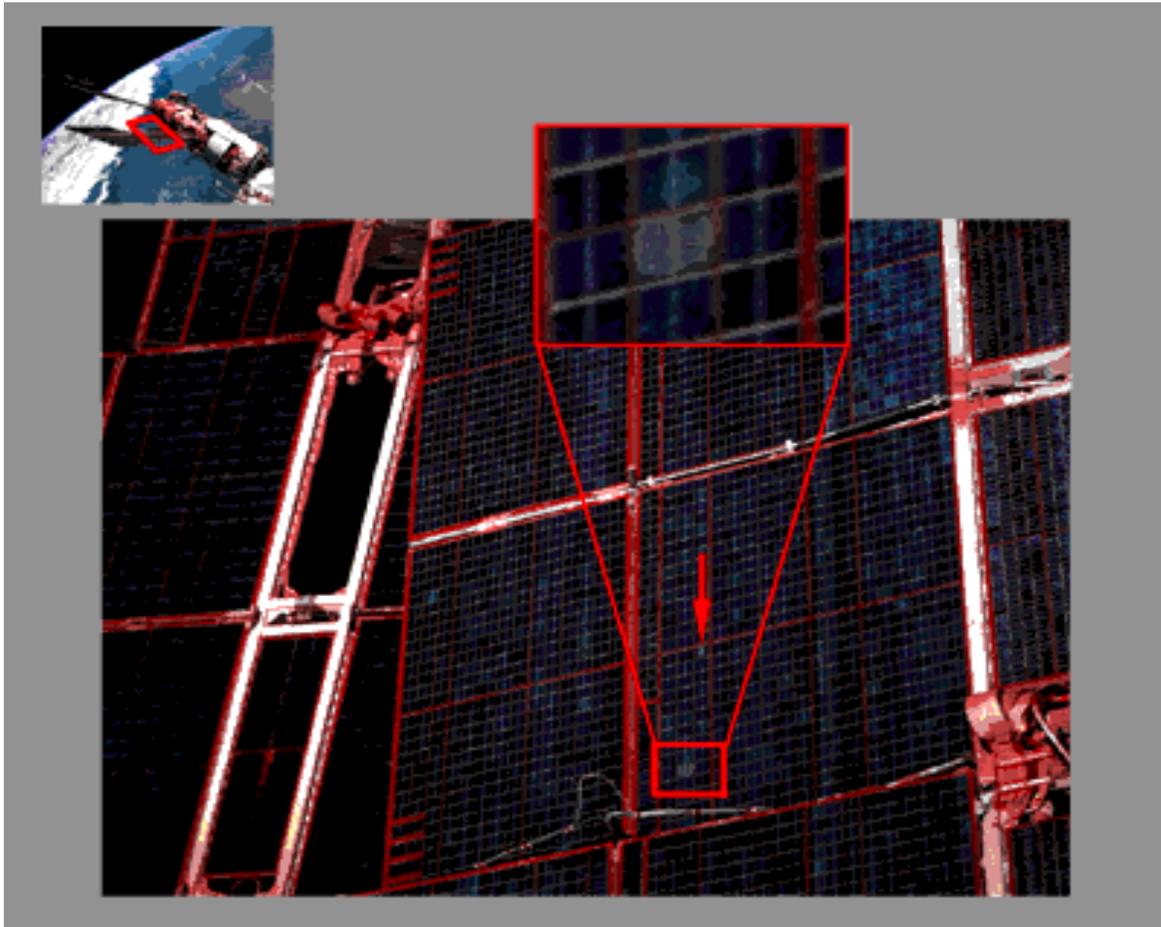
Figure 3-M SP#2 Spektr Solar Array

The enlarged region and the arrow on the solar array indicate areas where the solar array is lighter in color. The discoloration of the two cells in the enlarged region cover an area of approximately 8 cm². The area of discoloration pointed out by the arrow measures approximately 3 cm². There are at least 8 cells exhibiting this type of discoloration and the condition only appears to affect the surface of the cells.

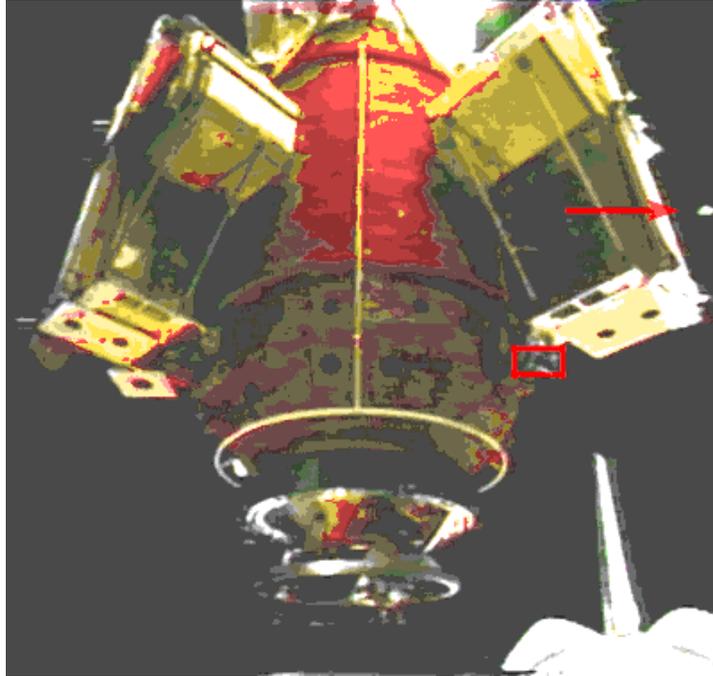
Figure 8-B Tumbling Debris from the Docking Module

Just prior to the docking ring capture, analysis was performed on a metallic-looking piece of debris that appeared to originate from a Cooperative Solar Array attach plate [identified by the box]. The debris appeared to be rotating and traveled towards the camera (located at the port forward corner of the Orbiter payload bay). The velocity of this single piece of debris was estimated at 5 inches per second. No damage was apparent on the available views.
