POSA I and II, and ESEM Flight Experiment Results

**Gary Pippin
Boeing ISDS**

**NASA SEE Workshop
Huntsville, Al
June 1998**

POSA (Passive Optical Sample Assembly) Experiments are part of an ISS Contamination Risk Mitigation Experiment

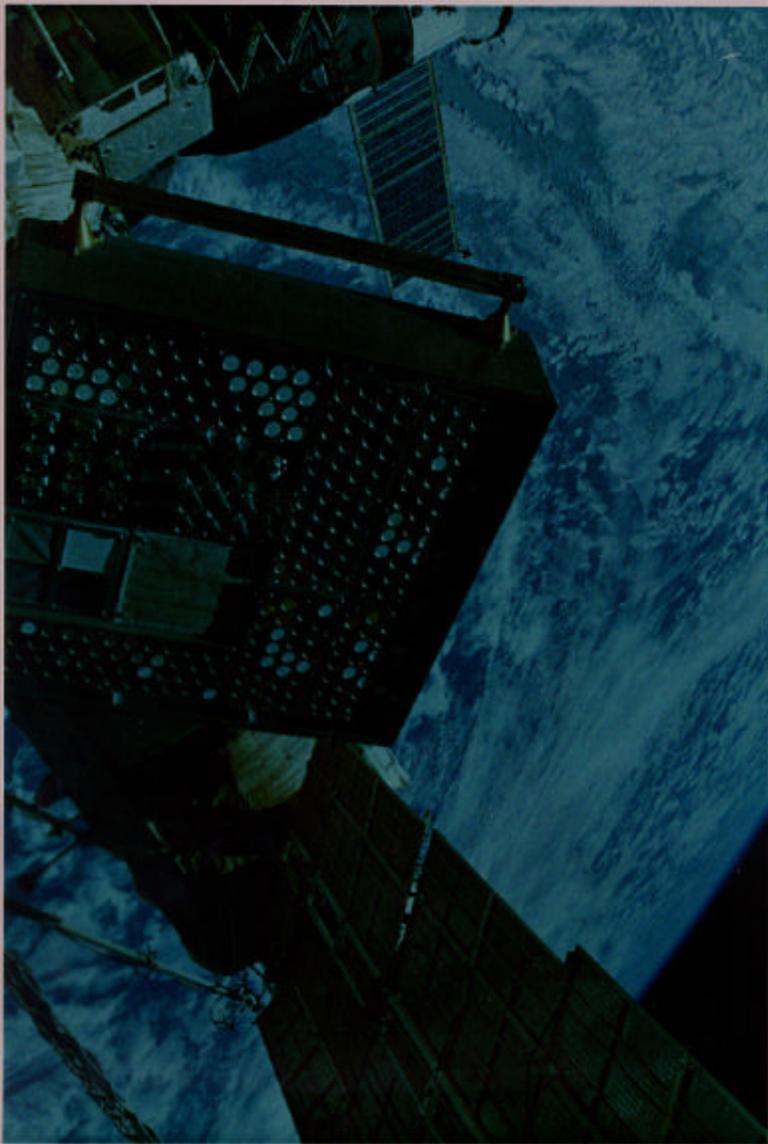
NASA On-Orbit photo of POSA II during retrieval

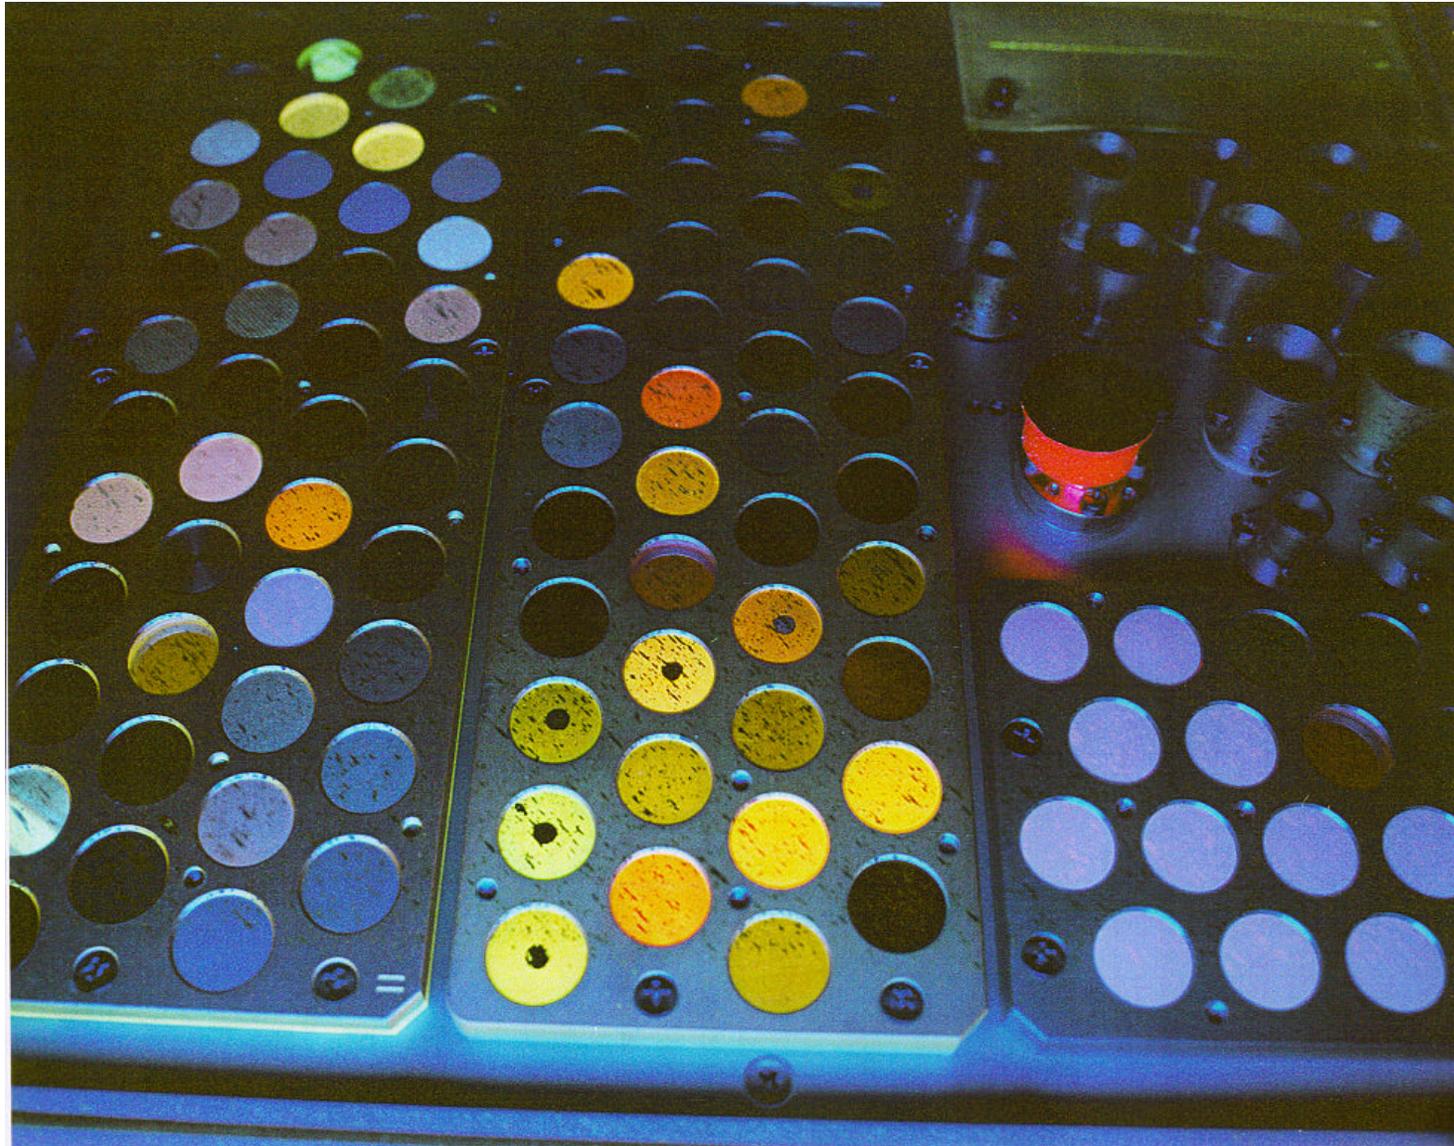
Black light post-flight photo of part of POSA II tray-space/space shuttle facing side
