SPIFEX Contamination Studies

May 1996

**National Aeronautics and
Space Administration**

**Lyndon B. Johnson Space Center
Houston, Texas**

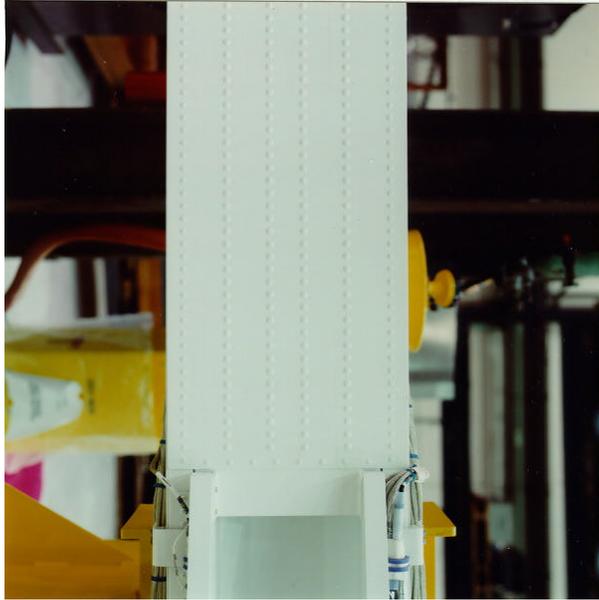
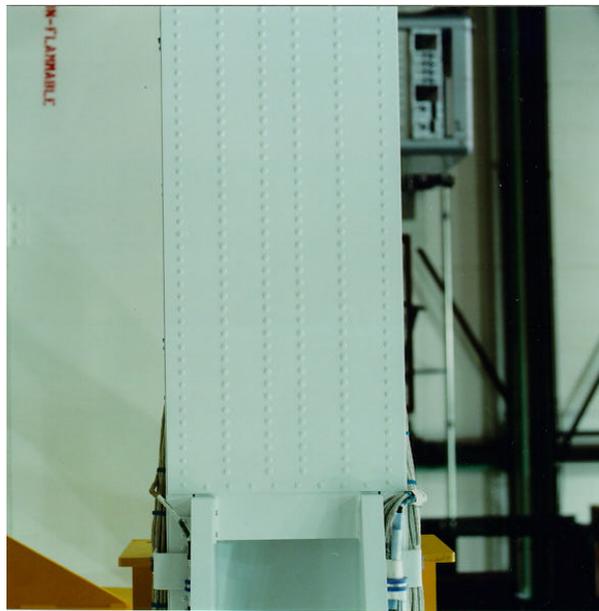
Figure 1a. NASA Photo S94-36825: Preflight

Figures 1a and 1b show photographs of a SPIFEX surface immediately adjacent to the payload plume sensor package both before (1a) and after (1b) the spaceflight experiment. The surface shown in the photograph is aluminum painted with A-276, a polyurethanebased white space paint. There is no evidence of damage from hypergolic engine plume impingement during SPIFEX either in the photo or by visual inspection.

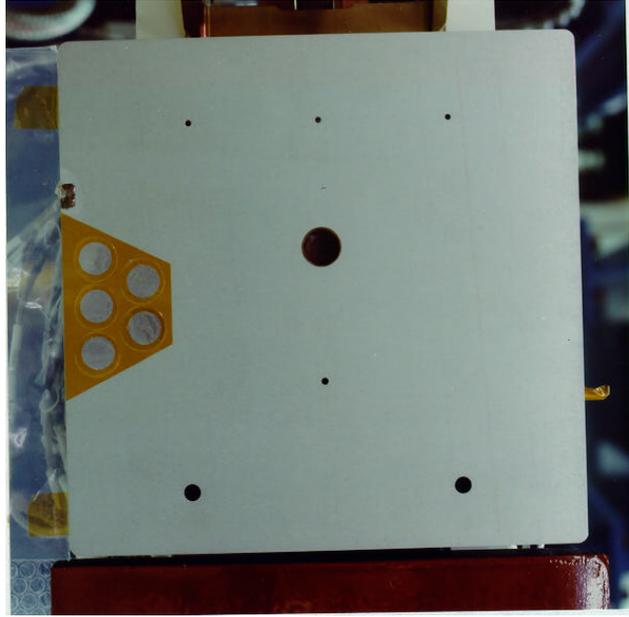
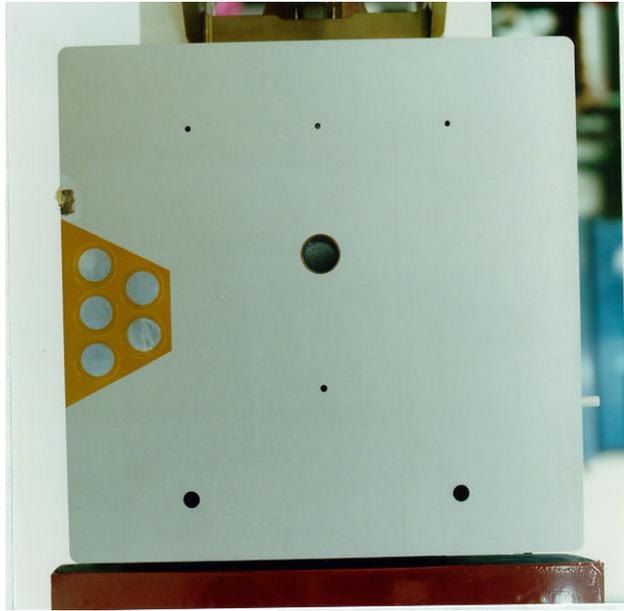
Figure 2a. NASA Photo S94-36824: Preflight

The preflight and postflight photos of the pressure measurement plate and the contamination measurement witness coupons, visible as five metallic disks in a trapezoidal Kapton™ tape coupon holder, are shown in figures 2a and 2b, respectively. Once again, little change in appearance is evident in the photographs, beyond the small changes attributable to changes in lighting conditions. Postflight visual inspection showed no change in appearance compared to the preflight appearance.

It is significant that the Kapton tape trapezoid holding down the witness coupons did not develop a diffuse surface, during the mission, as a result of atomic oxygen exposure. The absence of direct evidence of atomic oxygen attack is not surprising because SPIFEX operations were conducted at a relatively high altitude during solar minimum so that a total oxygen atom fluence of less than 10^{19} atoms/cm² was anticipated and that fluence is not sufficient to produce a diffuse surface on a glossy Kapton tape.

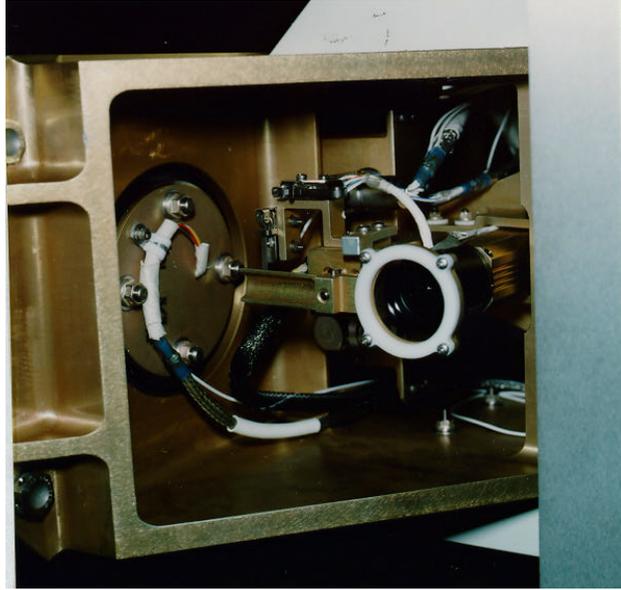
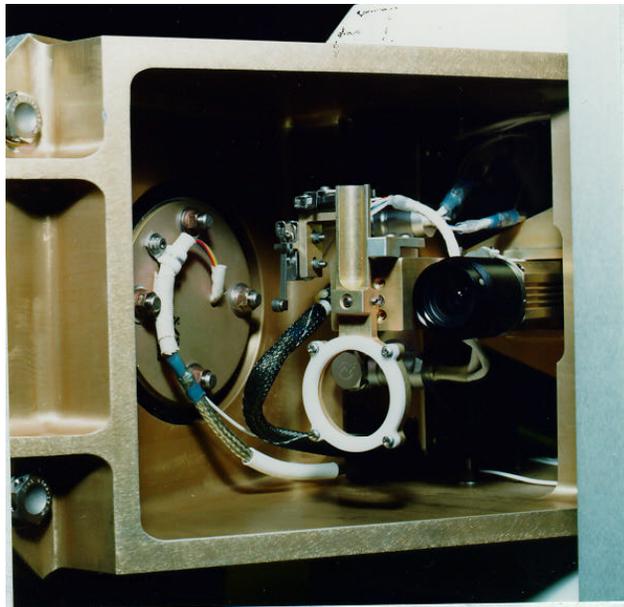
Figure 3a. NASA Photo S94-36829: Preflight

Figures 3 and 4 also compare the preflight and postflight appearance of SPIFEX hardware components which were exposed to hypergolic engine plume impingement. In all cases, visual inspection revealed little or no difference in the appearance of the various SPIFEX components resulting from the spaceflight experiment.

The video camera assembly shown in figure 3 reveals no evidence of degradation resulting from SPIFEX operations. The assembly was positioned within 20 cm of the witness coupons and received essentially the same engine plume impingement history. The nearly pristine appearance of this delicate instrument assembly supports the general conclusion of this report that the limited hypergolic engine plume impingement characteristic of proximity operations produces no gross materials or systems degradation. The quartz window held by the white circular Teflon™ ring visible in the photos was sent to NPO Energia for independent analysis of plume impingement effects.

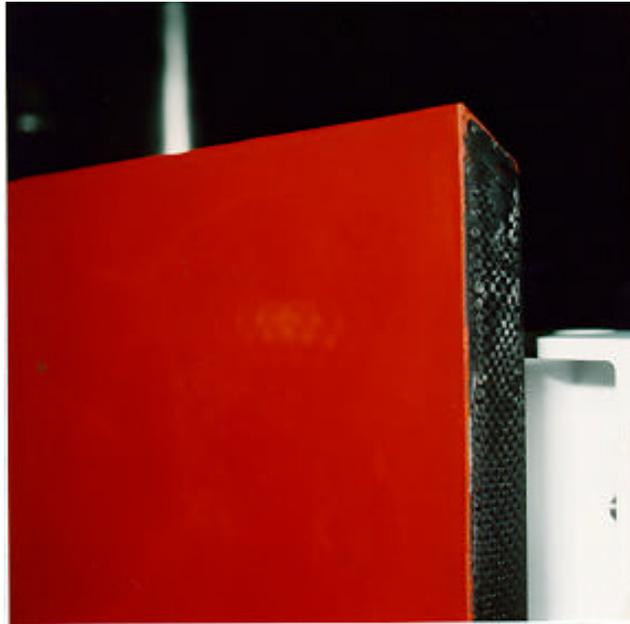
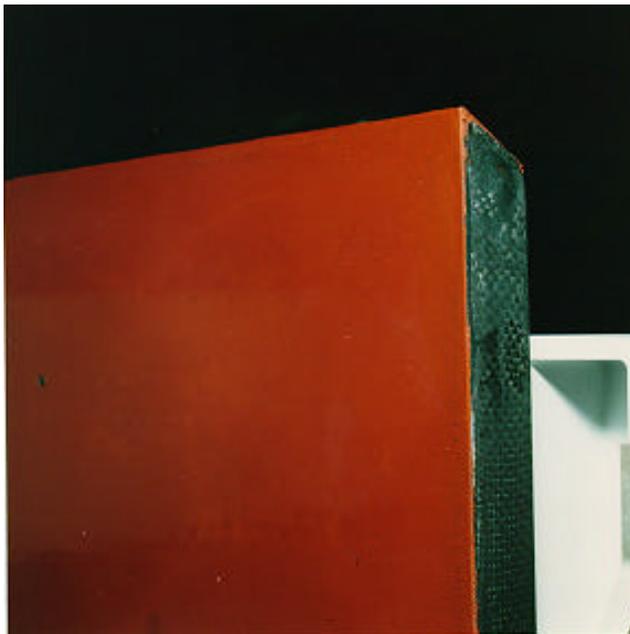
Figure 4a. NASA Photo S94 -36807: Preflight

The SiO_x-coated Kapton surface of the load measurement plate (figure 4) did show some slight variation in appearance, though not the darkening apparent in the figures (variation in photo lighting conditions). The appearance of some regions of the SiO_x-coated Kapton did change as a result of the spaceflight and is attributed to changes in the properties of the adhesive bonding surface. Thermo-optical property measurements on both the ground control and flight plates showed no significant difference between the two. Measurements of the solar absorptance, α , and the infrared emittance, ϵ , measured at five randomly selected points on each plate gave the results shown in table 2.

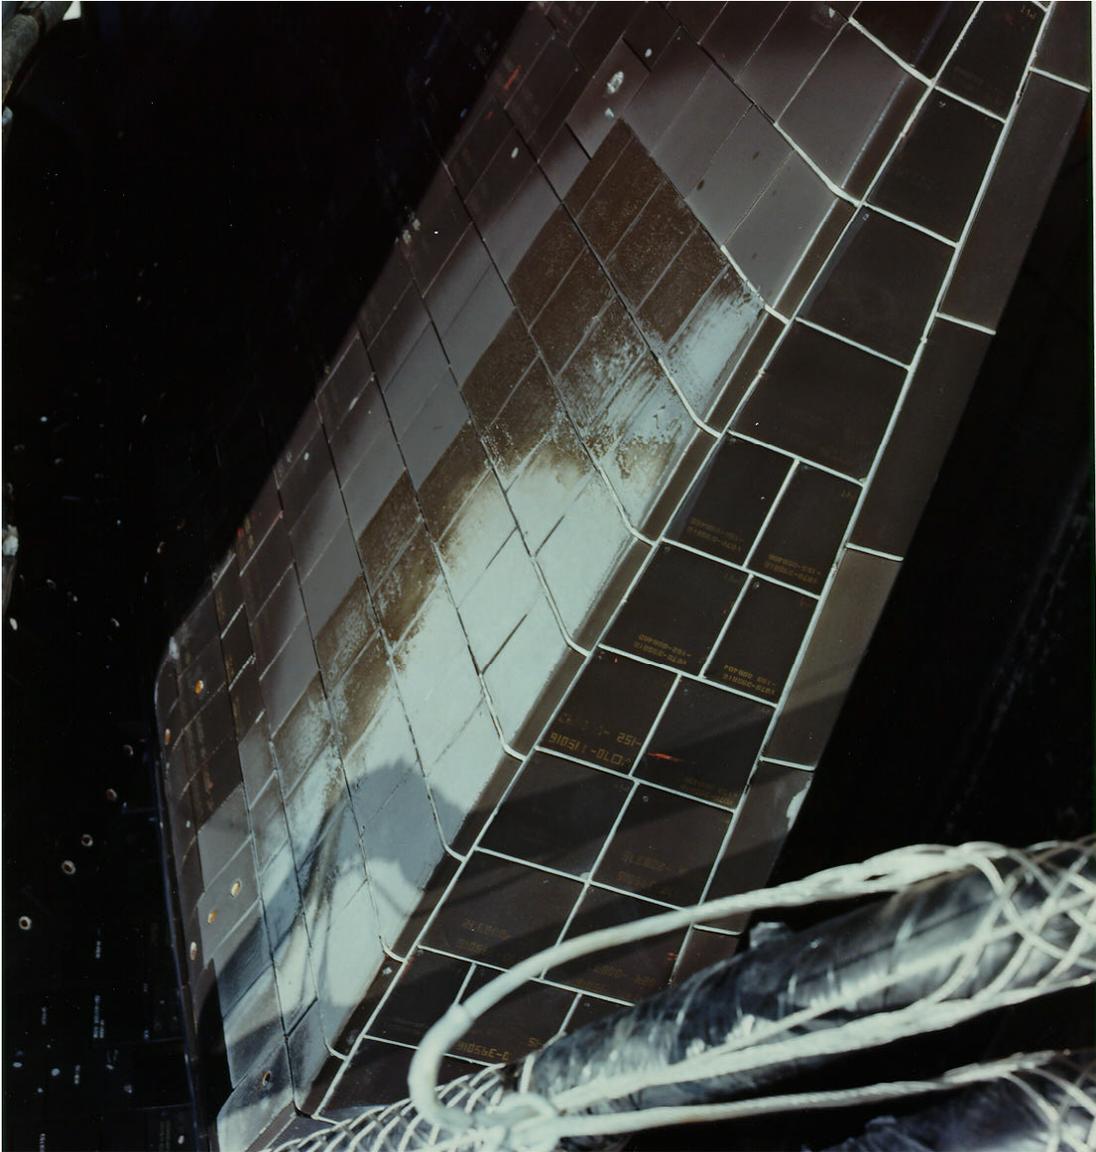
Figure 5. NASA Photo S83-29867: Damage to Orbiter body flap tiles

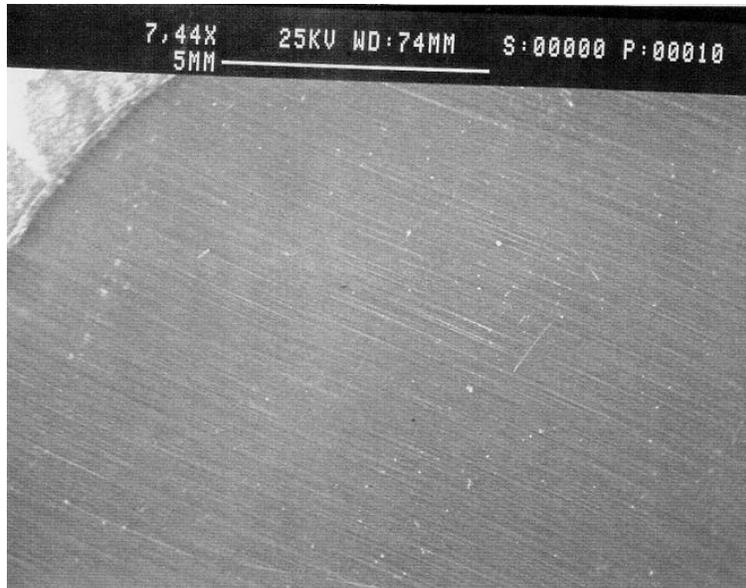
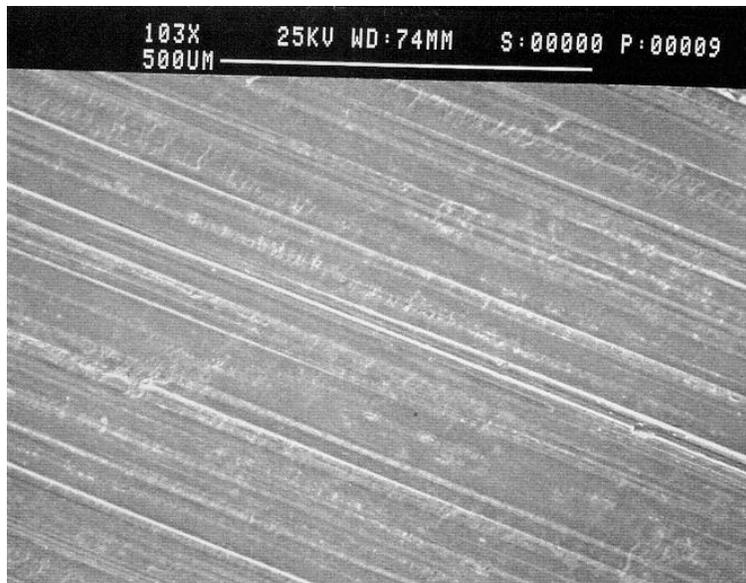
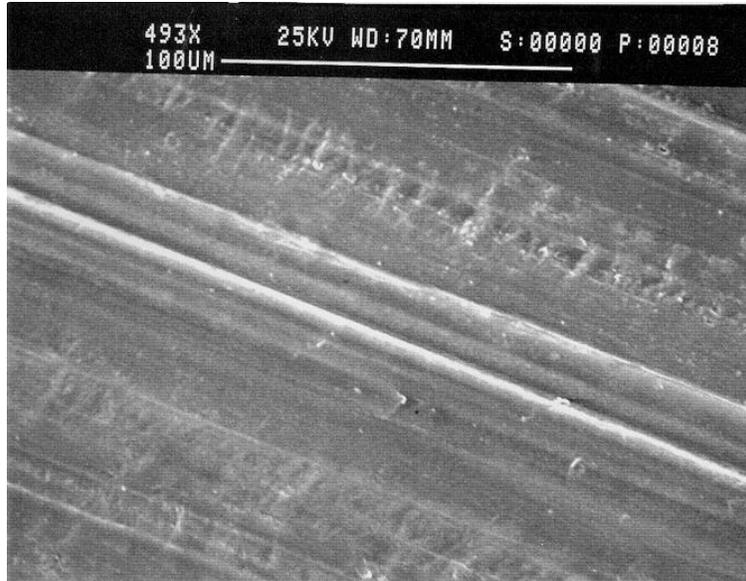
Figure 1-1. Control Sample 1, 7.44X

Figure 1-2. Control Sample 1, 103X

Figure 1-3. Control Sample 1, 493X

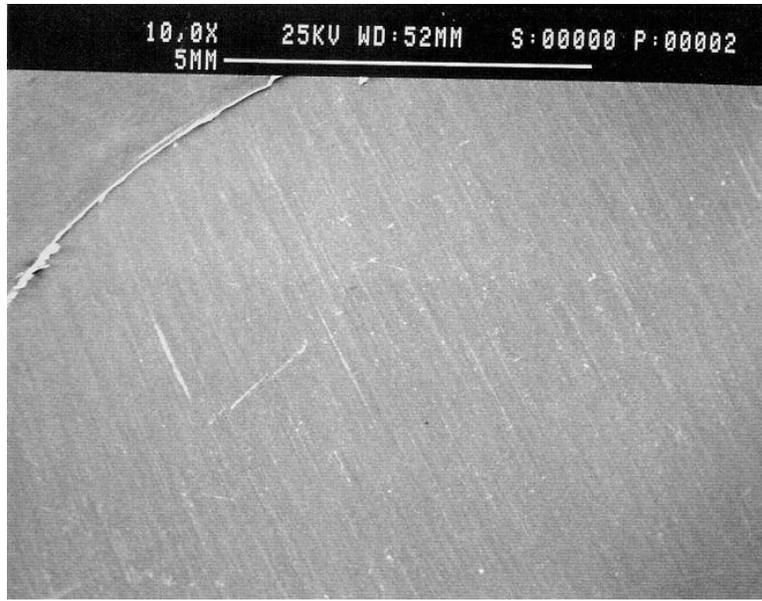
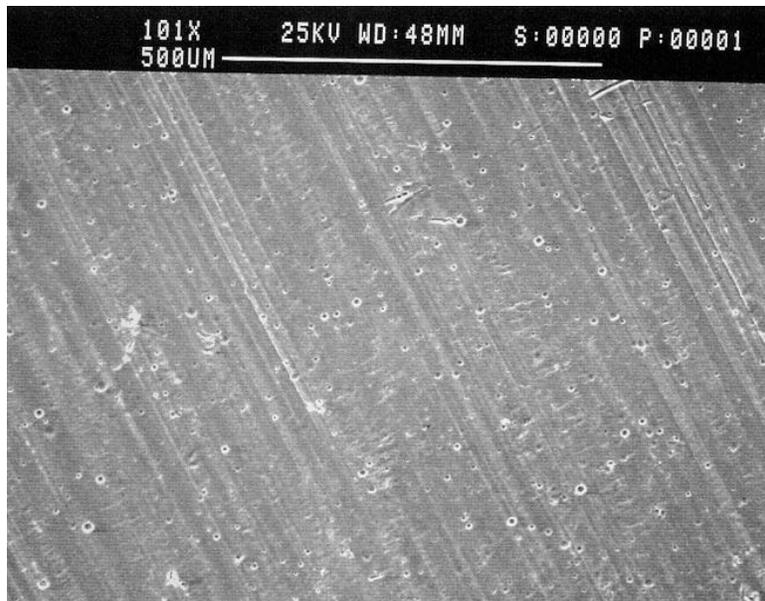
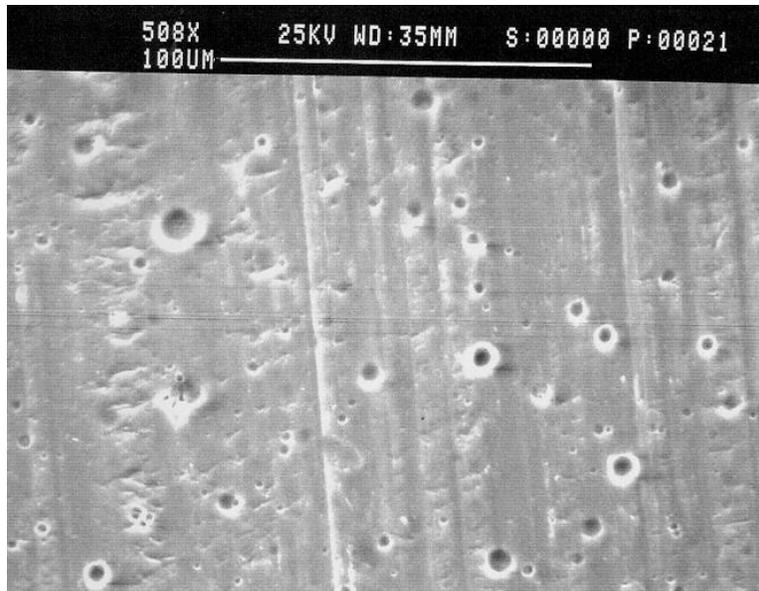
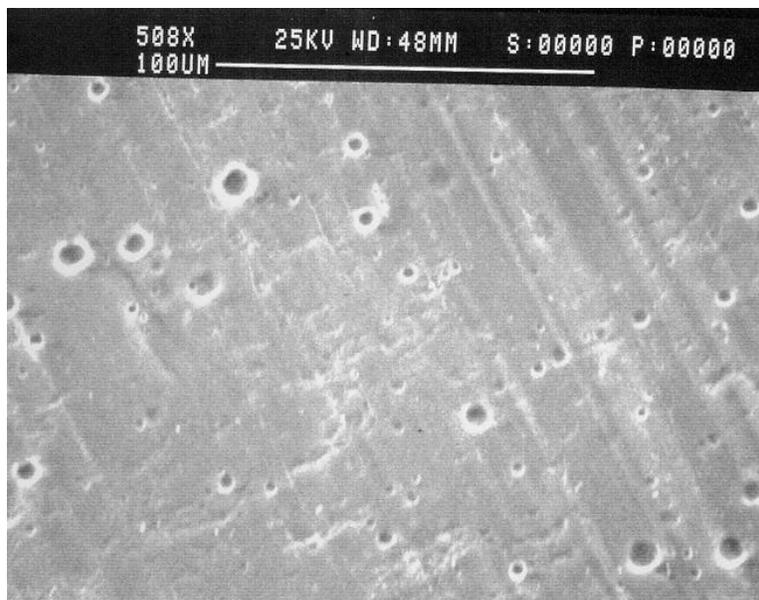
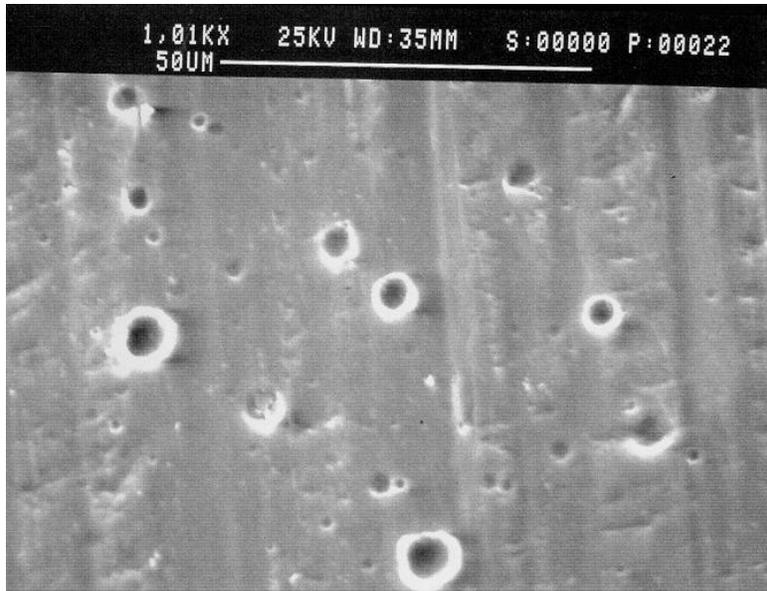
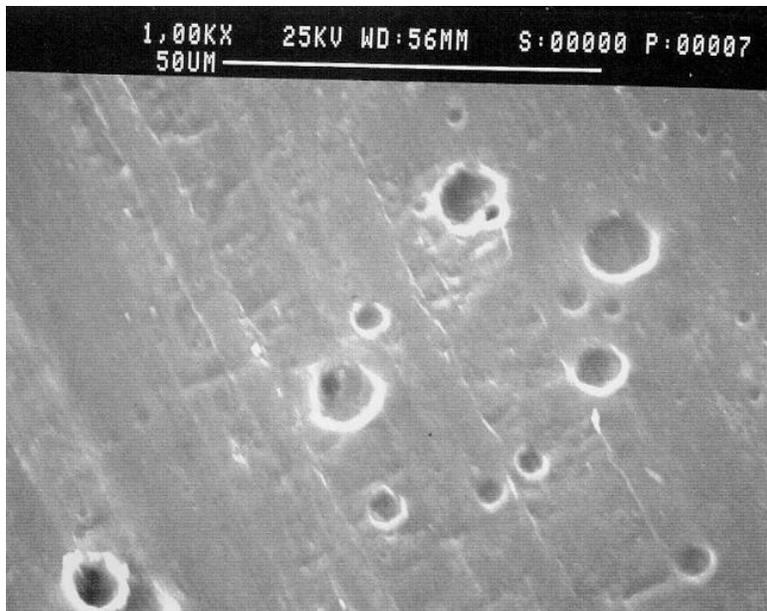
2.7 One control sample and the three witness coupons were examined using scanning electron microscope (SEM). Figures 1-22 show the surfaces of the aluminum control sample and the aluminum and Kapton for the three witness coupons. The control sample has a fairly smooth surface. The aluminum and Kapton surfaces have impact marks. The Kapton surfaces have crater-like "frozen splash" marks. The aluminum surfaces show shallow craters or dents. The craters and dents on both the Kapton and the aluminum surfaces appear to have been caused by drops of liquid impacting the surfaces at high velocity. EDS analyses within the

Figure 1-4. SPIFEX Witness Coupon 1, 10X

Figure 1-5. SPIFEX Witness Coupon 1, 101X

Figure 1-6 SPIFEX Witness Coupon 1, 508X

Figure 1-7. SPIFEX Witness Coupon 1, 508X

Figure 1-8. SPIFEX Witness Coupon 1, 1010X

Figure 1-9. SPIFEX Witness Coupon 1, 1000X

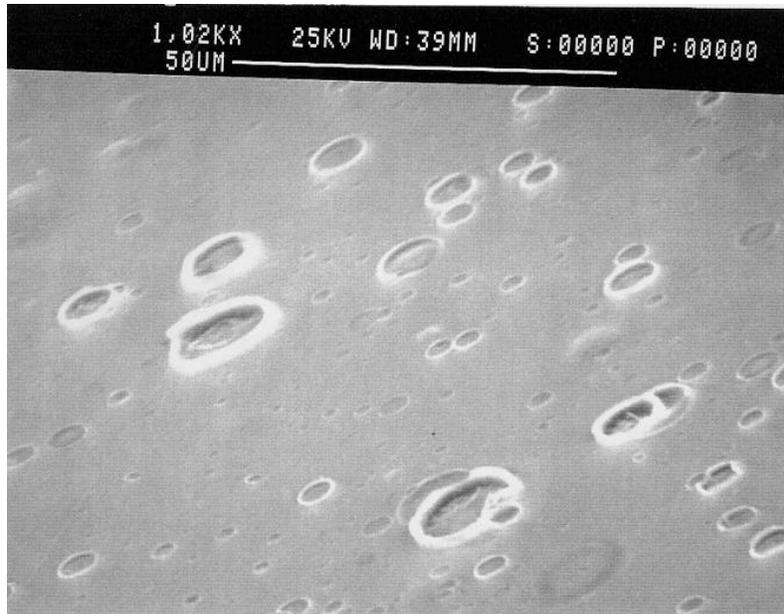
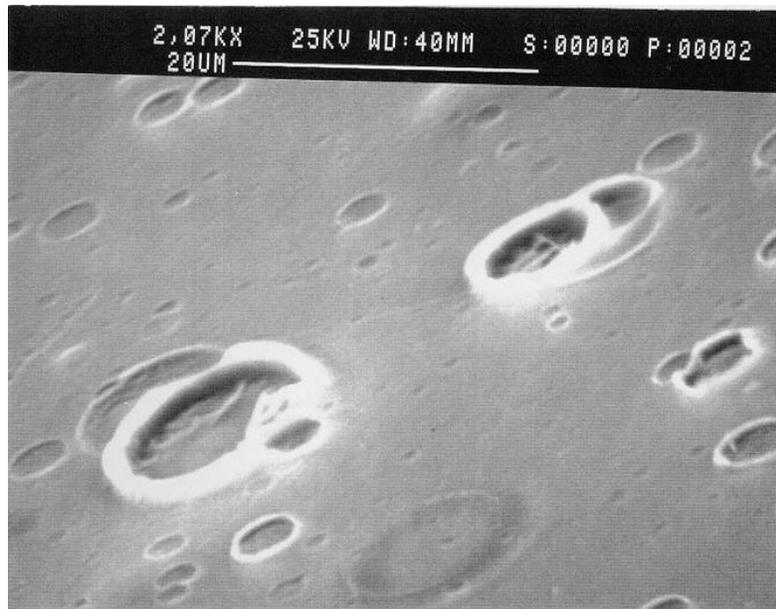
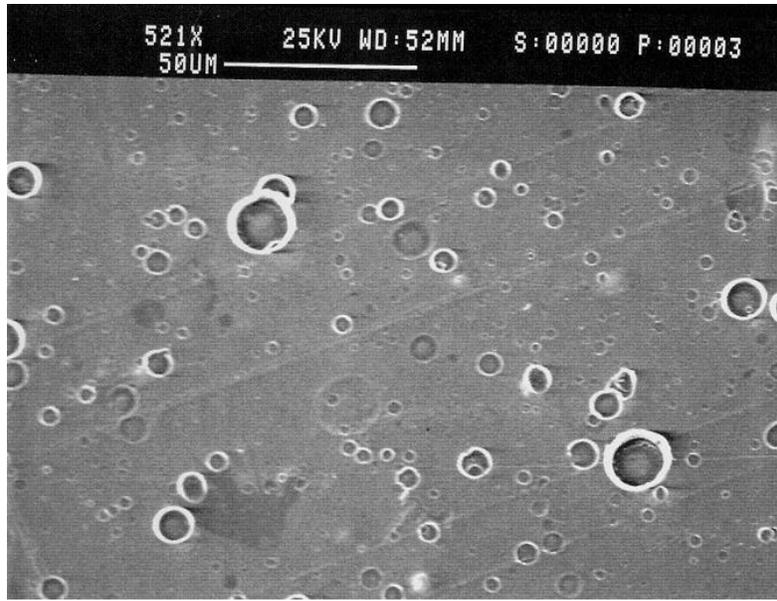
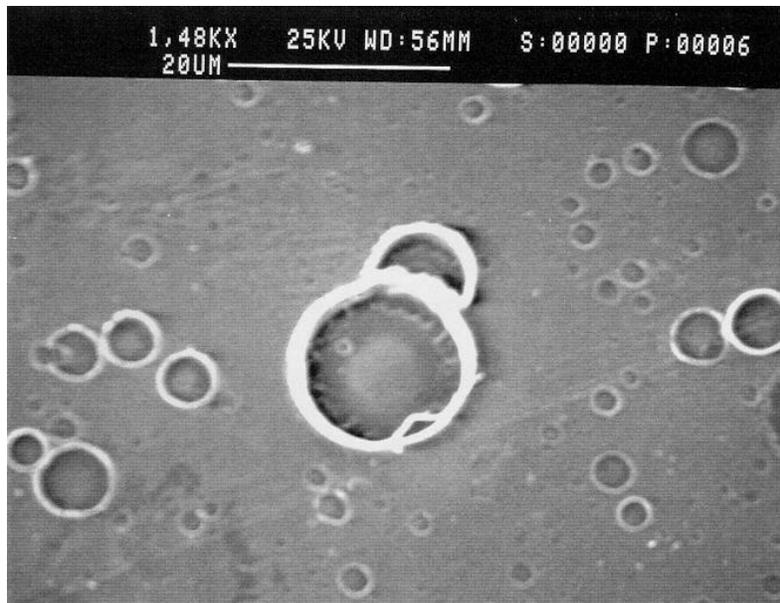
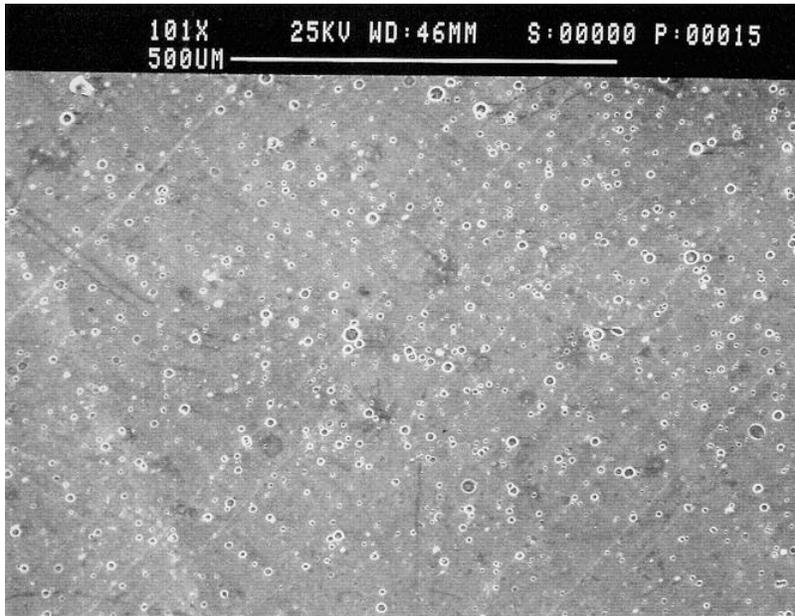
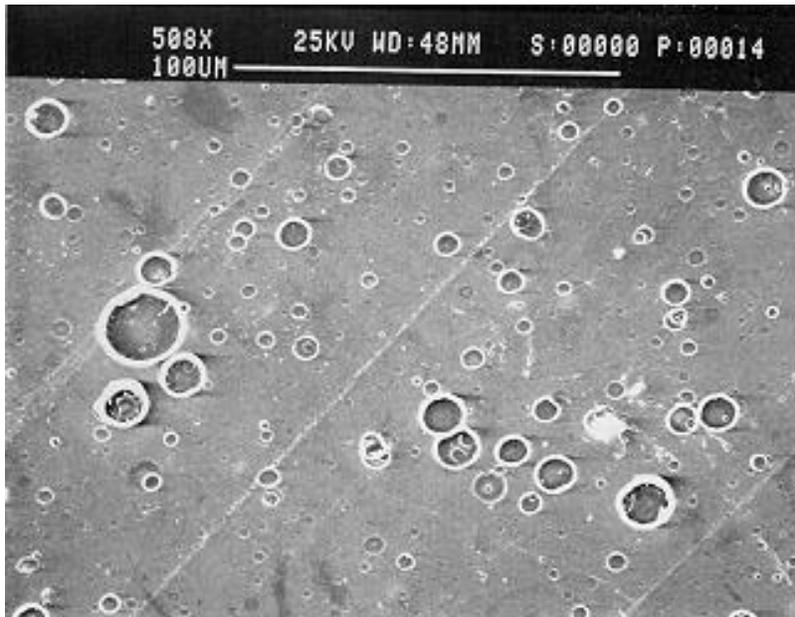
The craters on the Kapton appear to be the result of chemically reactive liquid droplets, probably MMH, impinging at moderate velocity. MMH rapidly dissolves Kapton and other polyimides even at relatively low temperatures. The smaller craters in the aluminum witness coupons were probably formed by impact of solid oxidizer ice particles.

Figure 1-10. Kapton from Witness Coupon 1, 75a, 1020X

Figure 1-11. Kapton from Witness Coupon 1, 75a, 2070X

Figure 1-14. Kapton from Witness Coupon 1, 521X

Figure 1-15. Kapton from Witness Coupon 1, 1480X

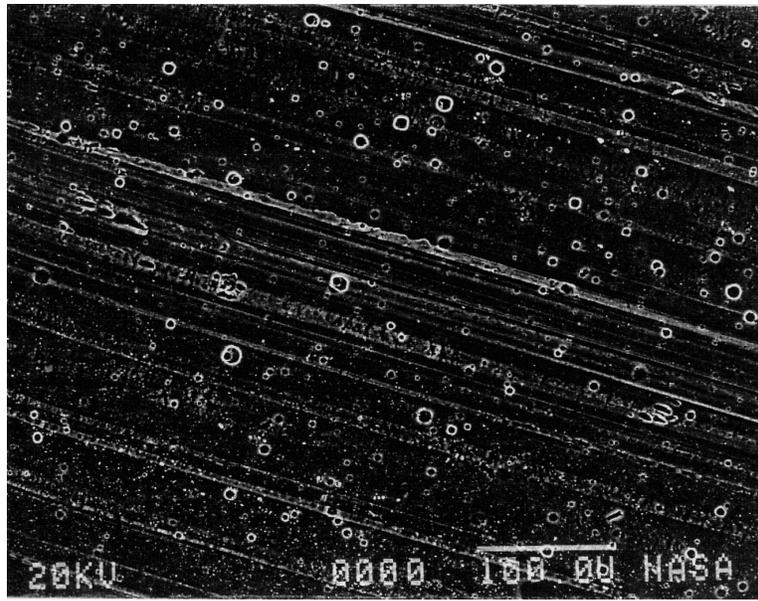
The Kapton tape sample had $1.3 \pm 0.3 \times 10^6$ impacts per square cm while the aluminum witness coupons had $4.4 \pm 0.9 \times 10^5$ impacts per square cm as determined by counting the craters in the 500X SEM photos. No impact features of any kind were found in the ground control samples.

No impact features were found in the ground control coupon. The first (and only) SPIFEX coupon examined had a high number density of small impact craters (Figure 2-1), although the surface was not saturated with craters. The craters generally measured less than 10 micrometers in diameter. Most impact features were typical round craters with raised rims (as shown in Figure 2-2); however, many elongate impact features were evident (Figure 2-3) indicating oblique impacts. Some of the smaller elongate features possibly represent secondary craters but this is speculation.

Figure 2-1. Typical view of SPIFEX flight coupon 1 showing many small craters.

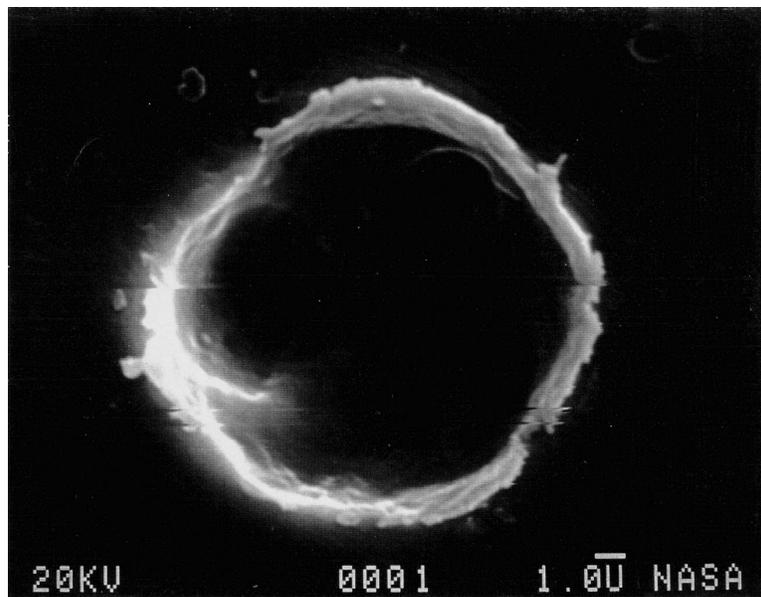
Figure 2-2. Typical round crater; this one contains no detectable impactor residue.

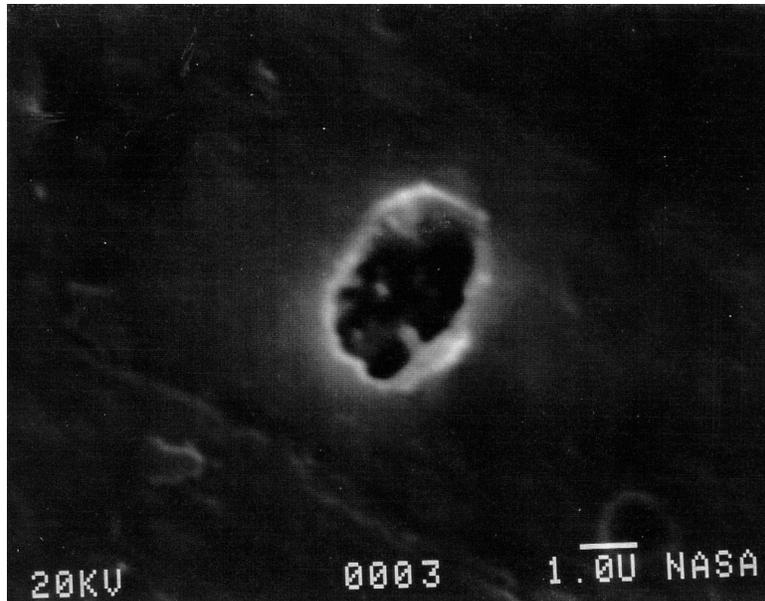
EDS analysis of approximately 100 impact crater interiors revealed that only about 5% contained any impactor residue material identifiable by this survey technique. Three craters contained solid material (interpreted as impactor residue) containing Fe in some form (Figure 2-4). Two craters contained Cr as a residue (Figure 2-3). That these residues contain Fe and Cr in the reduced state is speculation because an analysis for O was not performed to verify this.

Figure 2-3. Elliptical crater with Cr-containing grains (all measuring less than 0.3 micrometers), interpreted as forming from an oblique impact by a Cr-containing impactor.

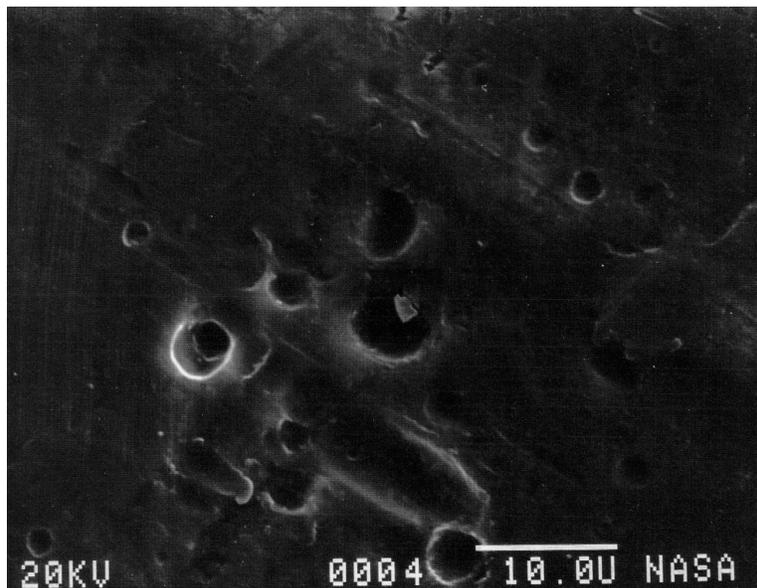
The SEM EDS results reported in Appendix 2 showed that only about 5 percent of the craters had any identifiable impactor residue (only the aluminum witness coupons were analyzed). In most cases, the impactor residue was Fe, though in two cases Cr was detected. The oxidation state of the metals was not determined. Iron and chromium nitrates are the principle corrosion product produced by N_2O_4 in contact with stainless steel and have been implicated in several in-flight failures (e.g., STS-63) of the PRCS-engine oxidizer flow-control valve.

Figure 2-4. The crater in the center has a small grain (approximately 1 micrometer) of Fe, interpreted as being residue from an Fe-bearing impactor.
