NASA Reference Publication 1374

Electronic Systems Failures and Anomalies Attributed to Electromagnetic Interference

R.D. Leach and M.B. Alexander, Editor

July 1995

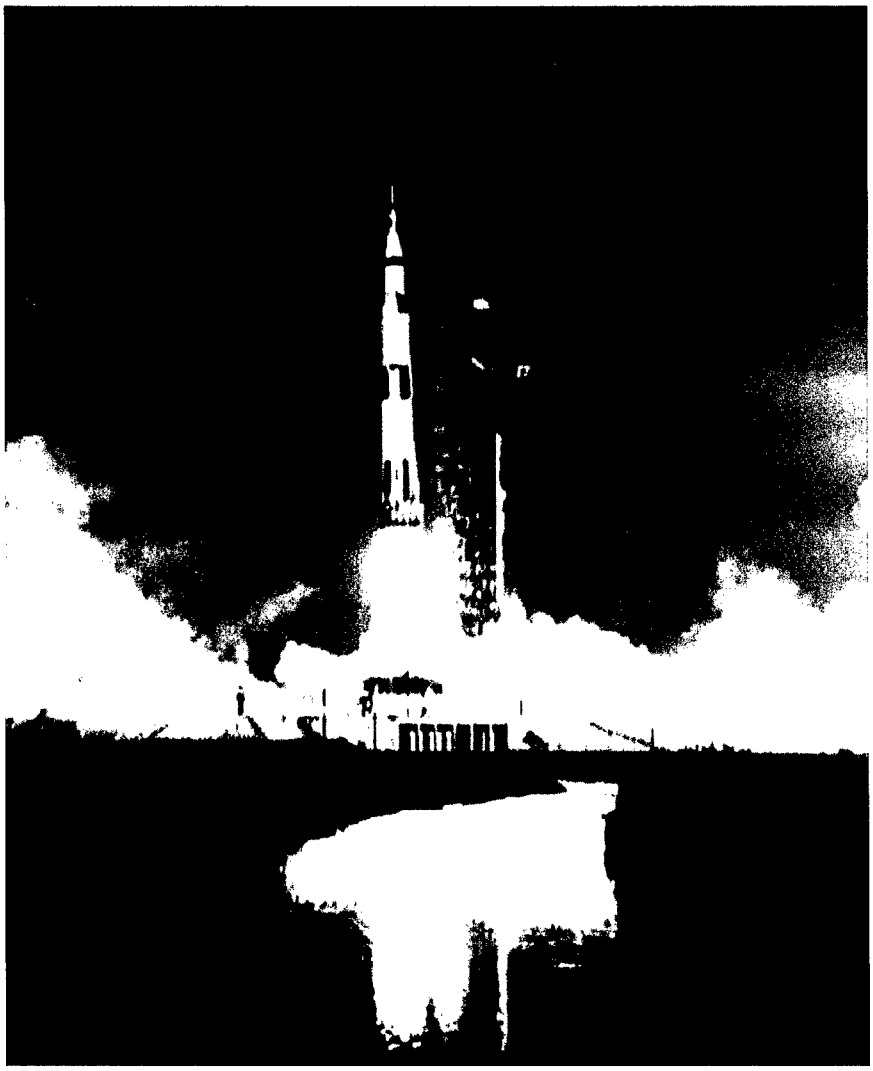
Figure 1. Saturn V launch.

During on-pad checkout at the Kennedy Space Center (KSC) prior to one of the early developmental test flights of the Saturn launch vehicle, the range safety receivers detected an extraneous signal. Because these receivers processed commands for engine cutoff, arm, and destruct, a thorough investigation was conducted to determine the cause of this unintended signal transmission. The problem appeared to be the production of spurious signals originating from the sum and difference combinations possible when signals frequencies are mixed. Although technically these spurious signals are not beat frequencies (associated with sound energy), this particular case is known within NASA as the beat frequency case and is maintained in this report by that title. The spurious signals were caused by the multitude of transmitters located on board to collect test data. Analysis determined that spurious signal frequencies very near the frequency of the range safety receivers were produced by a combination of frequencies from several telemetry transmitters in combination with one of the vehicle's tracking transponders. Further investigation determined that mixing sources for the signals were the hinged cable tray covers and chain handrails on the gantry. This insight and analysis proved to be useful later. With a Saturn vehicle on pad, the range safety receivers detected a spurious command signal for engine cutoff from a Titan launch vehicle checkout on the next pad. The Titan was using the same modulation frequencies on a different carrier frequency for its range safety receivers. A signal sent to the Titan vehicle was also received by the tracking transponder on the Saturn vehicle. The retransmitted signal of the transponder was mixed with certain telemetry signals resulting in the false engine cutoff command. After this incident, the decision was made to fly with the culprit transponder inactive (eventually it was removed from the vehicle). Later, both

telemetry and range safety transmissions were moved to a higher frequency range where the production of spurious signals did not interfere with the range safety system.[5]
