1. INTRODUCTION

1.1 Overview of Mir Photo/TV Survey

3. MIR SURVEY COVERAGE AND SURFACE ASSESSMENT

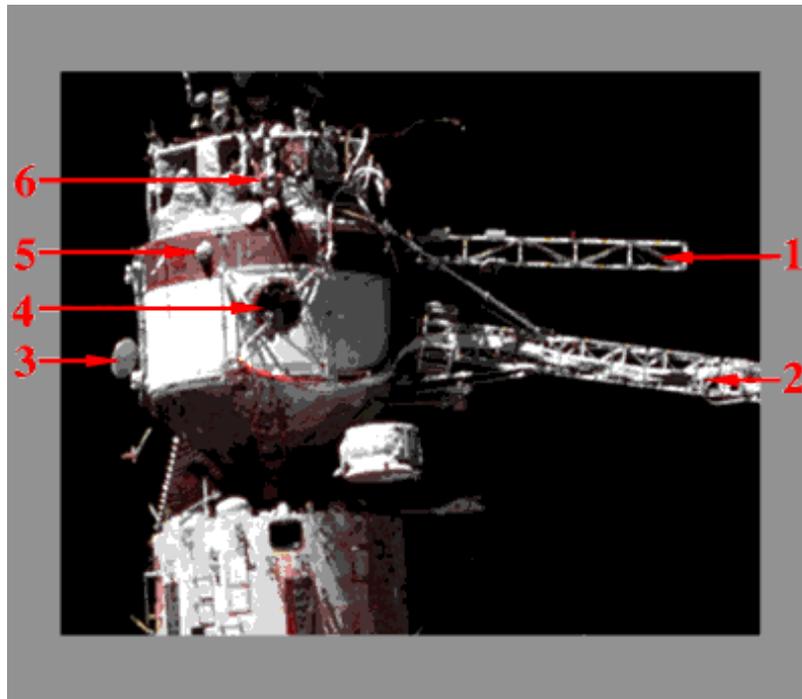
Figure 2-A Kvant

- 1. Rapana Truss***
- 2. Sofora Truss**
- 3. Window Cover**
- 4. Solar Array Attach Point**
- 5. Infrared Sensor**
- 6. Astrosensor**

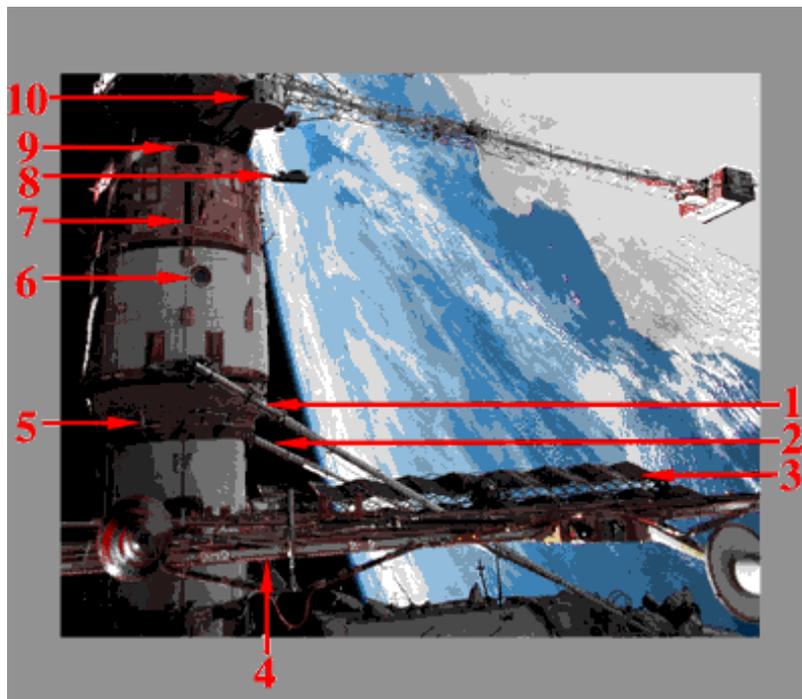
Figure 2-B Mir Base Block

- 1. New "Strehla" EVA Transfer Aid***
- 2. "Strehla" EVA Transfer Aid**
- 3. Base Block Array #3**
- 4. Base Block Array #2**
- 5. EVA Handrails**
- 6. Window**
- 7. Micrometeoroid Impact Sensor**
- 8. Approach & Rendezvous Antenna**
- 9. Attitude Control Thrusters**
- 10. Luch Antenna**

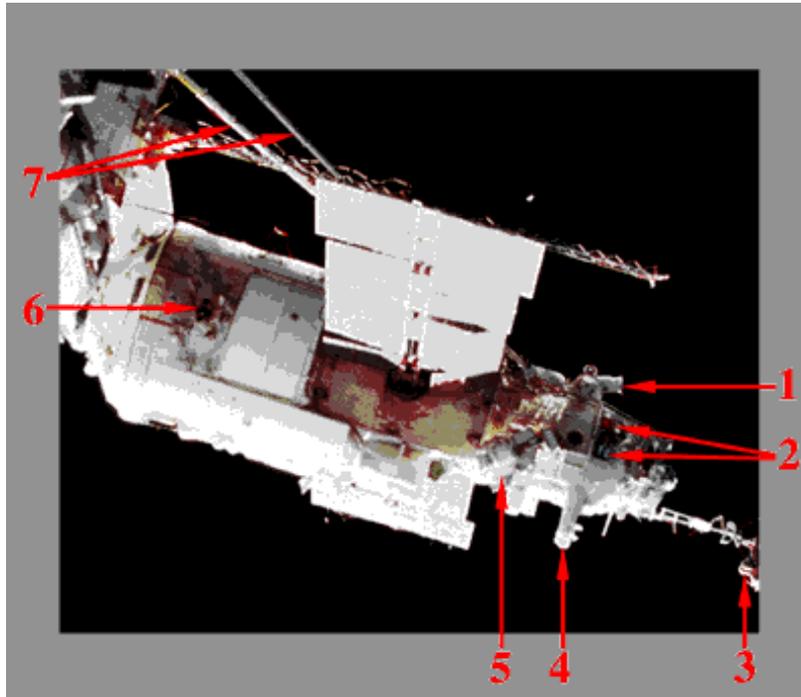
Figure 2-C Kvant-2

- 1. Star Orientation Sensor**
- 2. Materials Experiment**
- 3. Manned Maneuvering Unit***
- 4. Infrared Orientation Device**
- 5. Television Camera**
- 6. Attitude Control Engines**
- 7. “Strehla” EVA Transfer Aids**

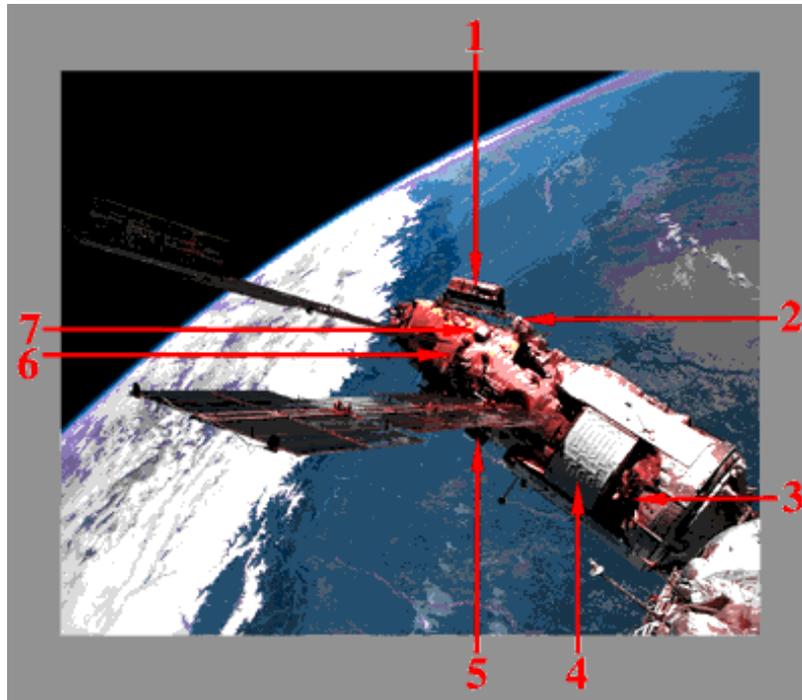
Figure 2-D Spektr

- 1. Belgian Mass Spectrometer (MIRAS)***
- 2. *Unknown***
- 3. Precision Attitude Control Thrusters**
- 4. Radiator**
- 5. Payload Pointing System**
- 6. Attitude Control & Docking Thrusters**
- 7. *Unknown***

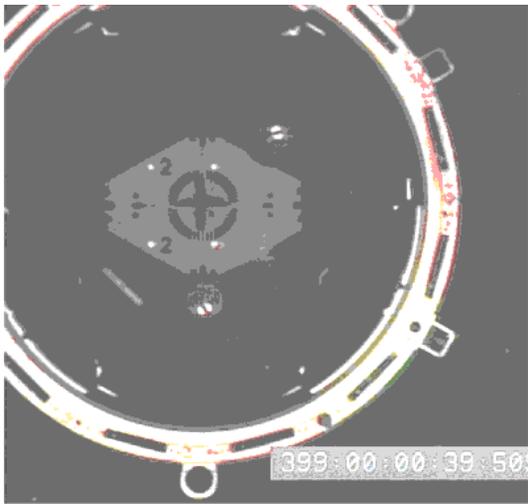
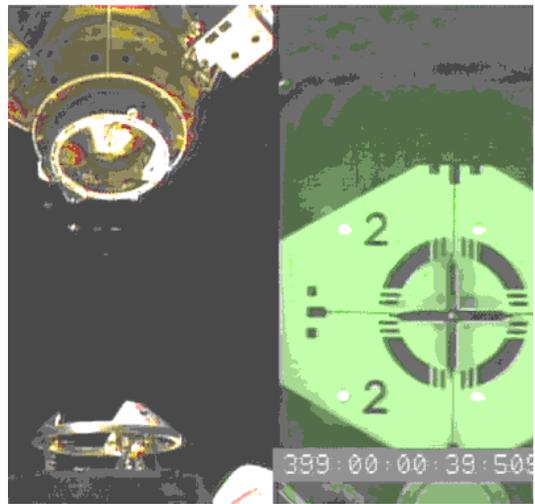
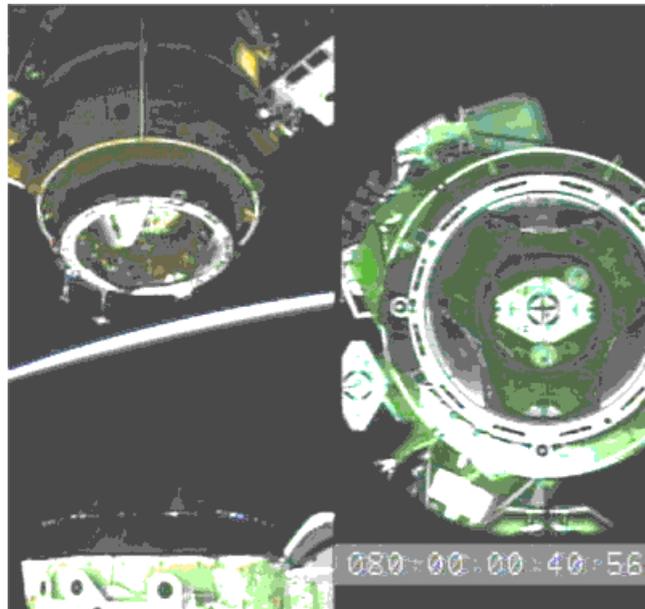
Due to crew time restraints during final approach, no Hasselblad (70 mm) or Electronic Still Camera (ESC) photographs of the APDU were acquired. Based on the limited video views available, the structural latches, capture latches, body-mounted latches, alignment guides, laser retroreflectors, fluid/electrical socket/plug, and the centerline target all appeared to be in good condition on backaway.

Since the primary function of the ODS centerline camera was to provide the crew with a means to visually align the target during approach, zoom settings were manipulated at their discretion. Note the zoomed in field-of-view setting of the centerline camera on approach as compared to the backaway. Also, as is the case with all multiplexed views involving the CTVC cameras, the downlinked frames seen on Figures 4-B and 4-C show a color imbalance which is normally corrected in post-processing of the video.

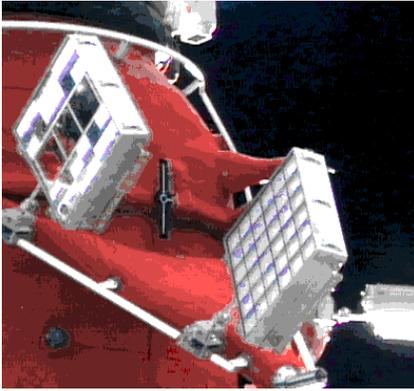
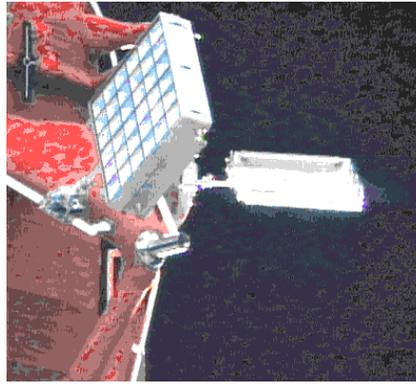
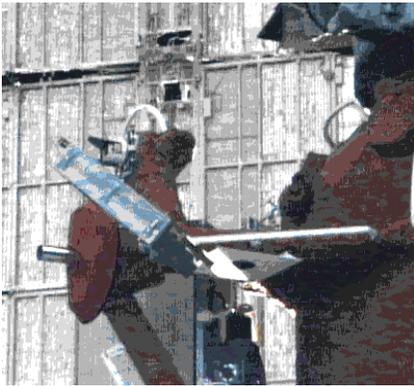
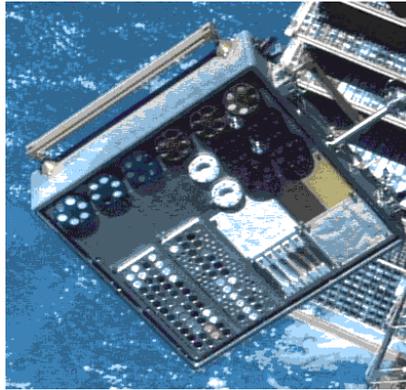
Figure 5-B MEEP Panels as Seen from PLB Cameras B and D

A summary of the available video views is shown in Figure 5-B and 5-C. Note that only the POSA surface could be seen unobstructed from any of the payload bay cameras. This view (from camera D) verified that no visible surface damage occurred to the POSA during installation. All other panels were seen edge-on from the aft cameras. These views do not allow analysis of surface assessment of the other panels. However, none of the panel sides shown in the accompanying digitized video images exhibit surface damage. Similar surveys performed on subsequent missions will try to determine the extent of surface discoloration and damage as a function of time.

The images above show the best views of each panel from the available CTVC cameras. All but the bottom right image was acquired from camera B located in the aft port corner of the payload bay. The remaining view was obtained from camera D, located in the forward starboard corner of the payload bay. Each of the camera B views was acquired at full zoom, while the camera D view was set to maximize panel features within the field-of-view. Only the Orbiter-facing sides of the PPMD, ODC and POSA panels were seen on these views. No damage was detected on the visible edges or flat surfaces based on these views.

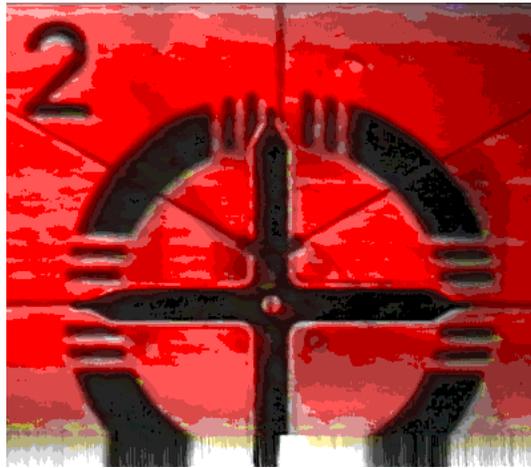
Figure 6-A Centerline Video at First Contact

The crosshair alignment washer seen on the centerline video exhibits motion at the time of first contact with the Mir docking interface. Figure 6-A shows the centerline video view used in the analysis. Data was acquired over a 25-second interval. Edge-detection algorithms were used to track where the projected crosshair lines would intersect on each frame. Motion was measured using this intersection point for each frame with respect to the reference point (the fixed center of the alignment target). The distortions on the bottom of the video frame were attributed to problems with one of the onboard recorders.

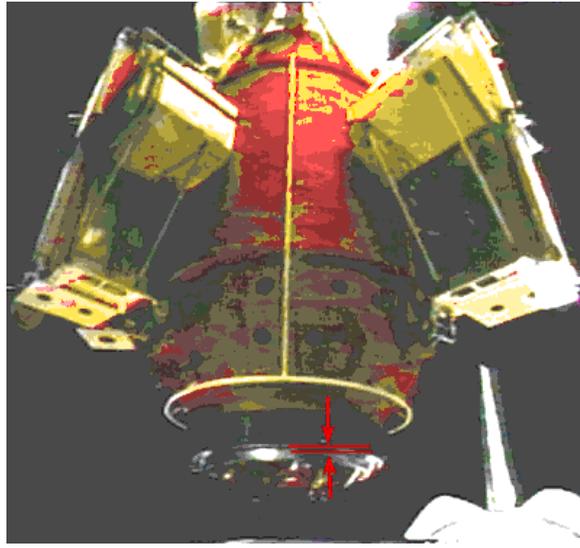
Figure 6-B Docking Ring Interface at First Contact

An effort was also made to quantify the separation distance between the Orbiter and Mir docking rings through the time of initial contact. The arrows in Figure 6-B identify this distance on a camera A view. However, the actual analysis was performed on the centerline video data. The Mir standoff docking target was used as a scaling factor and the camera image plane location was estimated and used as the reference point to determine separation distance at the interface. In addition, the lateral motion of the standoff docking target was determined by measuring the distance between the center of the standoff docking target and the fixed center point of the image frame.

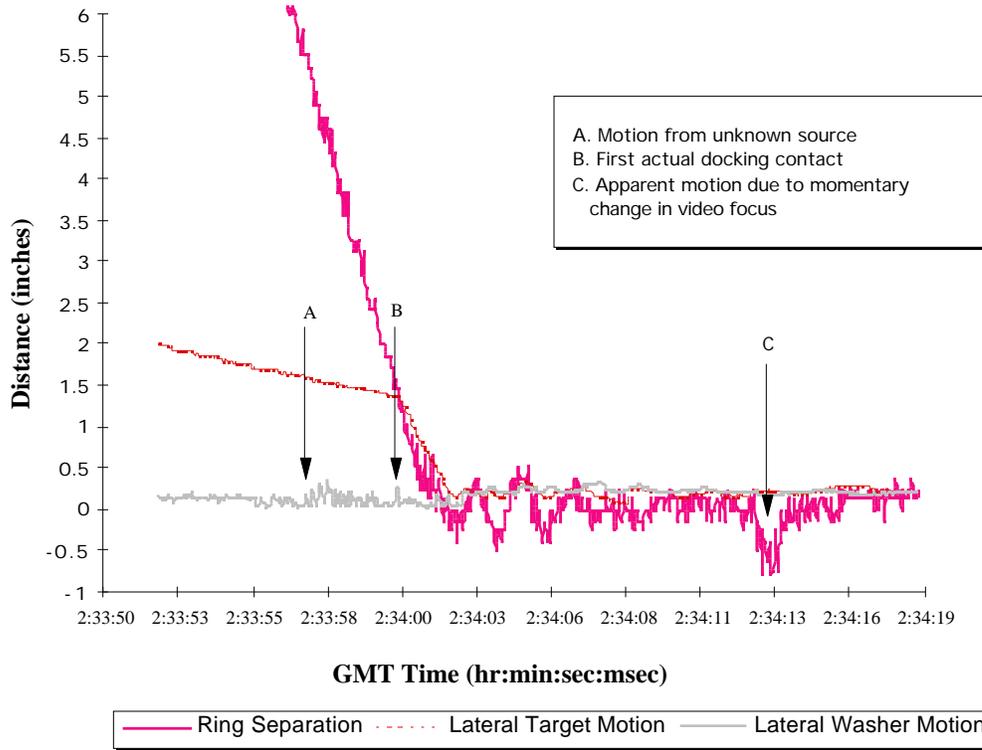
Figure 6-C Motion Analysis at Docking as a Function of Time

Figure 6-C shows the lateral motion of both the alignment washer and the standoff docking target, as well as the docking ring separation distance as a function of time. The separation distance was calculated based on an estimate of the camera image plane location and could account for the small negative numbers seen after first contact. Every video frame was used in the analysis for a period of approximately 26 seconds (or about 800 frames). Based on this data, the first contact between the Orbiter and Mir docking rings occurred at point 'B'. This information was forwarded to Structures and Dynamics engineers for additional assessment.

Data in the vertical interval of the recorded video contains horizontal field-of-view information which is accurate to +/- 1 degree. This information is used in the calculation of the camera focal length and could contribute to errors in the analysis. Other sources of error could be attributed to an inaccurate estimate of the effective focal length of the camera (due to a lack of complete camera information) and the variability in focus at the time of docking. Although automated routines were used in the tracking of edges for this analysis, changes in the focus caused the apparent edge position to change creating false motion in the collected data (as seen in Figure 6-C).
